FINAL REPORT

Glider Accident

ASW 27

Registration mark D-0759

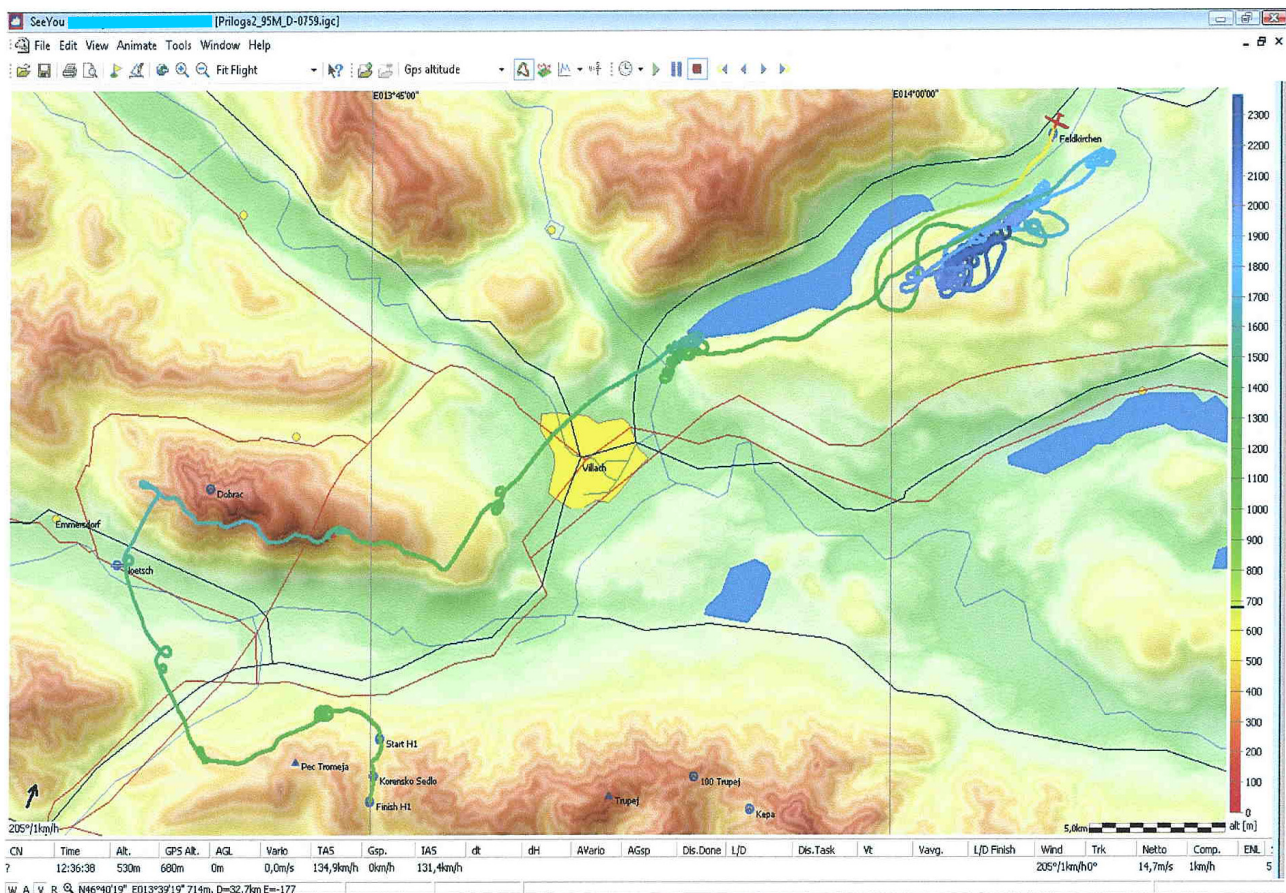
Image 1: Record of total flight route showed on vectorial map of field

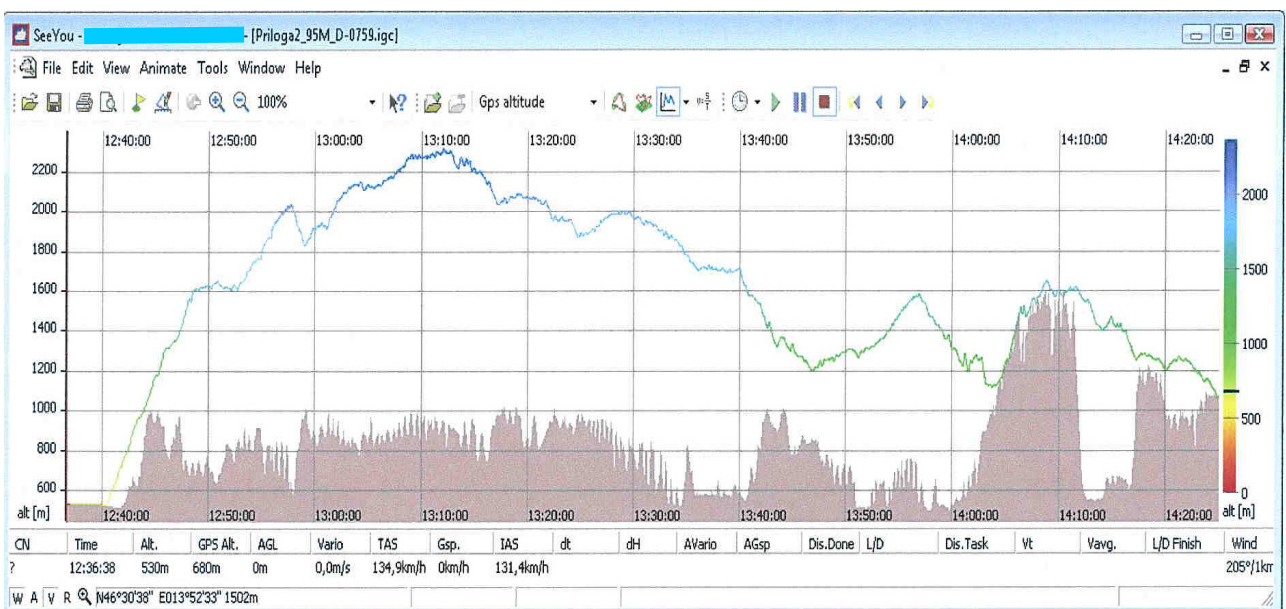
Image 2: Barogram of total flight, brown surface is presenting ground vertically under a plane
