Number: 37201-1/2013/21 – 00121019

Date: 24.06.2013

FINAL REPORT
OF A SERIOUS INCIDENT
Diamond DA 40
Registration OE-DKK on 01.03.2013
at Near Maribor Airport – LJMB

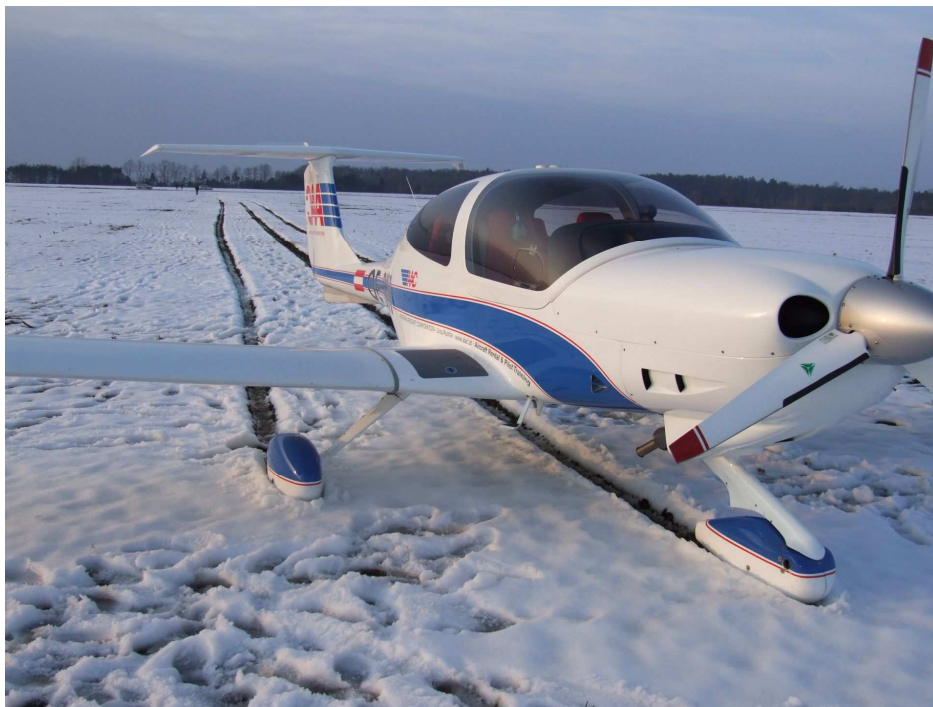
The pilot decided to land immediately in the direction of the snow-covered terrain without obstacles approximately 2 km south of the elevation runway. The pilot stopped the engine after landing and together with the passenger they sought help and reported the incident to the nearby police station. The Aircraft and crew did not suffer any injuries.

Figure 1- Emergency landing 2,5 km south in the RWY
