FINAL REPORT

ON THE INVESTIGATION OF THE AIRCRAFT Air Tractor AT-802 Fire Boss, reg. mark S5-BZR, on Portorož airport - LJPZ, July 22, 2024

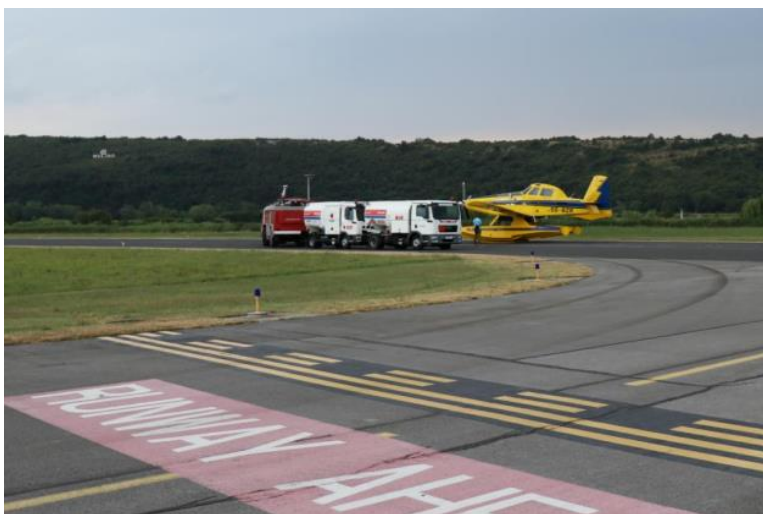
Slika 1: S5-BZR at the stopping point after landing at LJPZ²

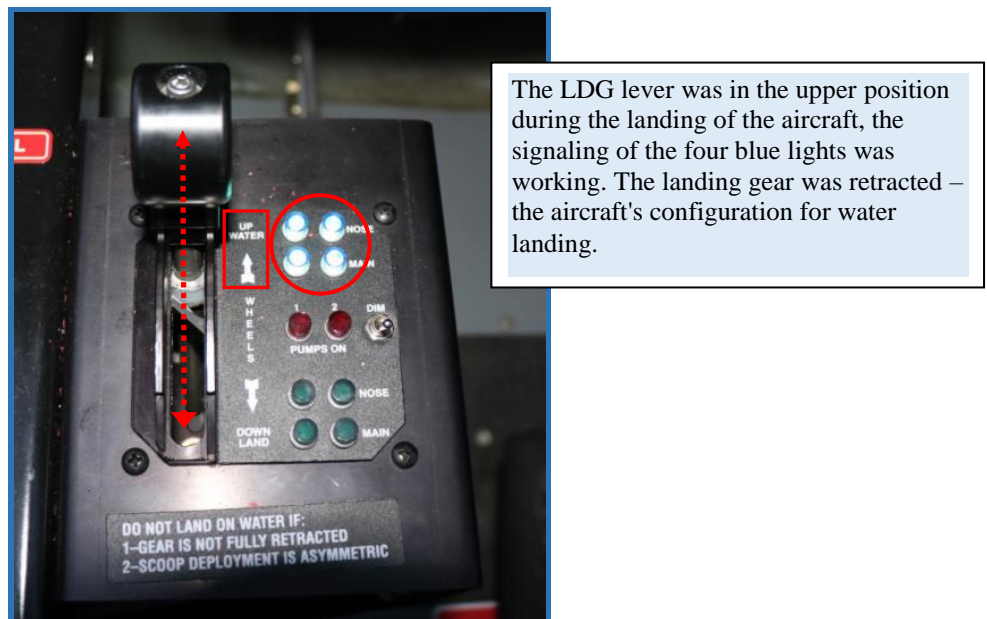
Upon inspecting the aircraft immediately after the incident, it was found that the LDG lever was in the retracted position, indicating that the landing gear configuration was set for a water landing.

Analysis of the operation of the LDG lever revealed no malfunction in its operation. The mechanism for deploying the landing gear worked correctly. Additionally, a review of the aircraft's maintenance documentation found no comments or indications of technical issues with the retractable landing gear system.

Slika 10: The position of the LDG lever in the cabin of the S5-BZR aircraft immediately after the event
