AIR, MARINE AND RAILWAY ACCIDENT AND INCIDENT INVESTIGATION UNIT

## OBVESTILO O ZAKLJUČKU PREISKAVE

### The accident of a glider DG-100 G Elan, reg. D-2964, June 14, 2024, Moškanjci – Ptuj Airfield (LJPT)

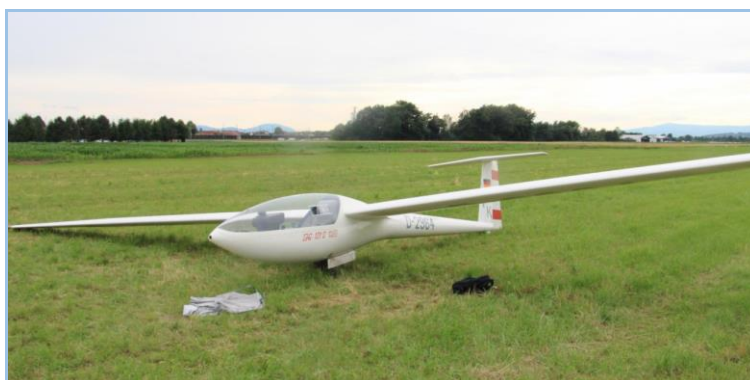
The pilot took off in an aerotow with the DG-100 G Elan glider at 13:09, heading runway 11 at Ptuj Airfield. After several minutes of soaring within the airport zone, the pilot safely landed at 13:25. The flight was uneventful. After landing, the pilot remained in the cockpit, preparing for another takeoff, which took place at 13:46. The aerotow during the second takeoff proceeded normally and without any irregularities until the moment the pilot, immediately after takeoff, realized that the airbrakes were in the extended position. According to the pilot's statement, the airbrakes unexpectedly deployed at an altitude of approximately 10 to 15 meters above runway. As a result, the aircraft pitched downward, struck the grass runway with the wheel, bounced, and impacted the grass runway multiple times with the lower fuselage. The pilot then released the tow rope and aborted the takeoff. The towplane (Super Cub) continued its climb and landed safely after releasing the tow rope. The incident resulted in material damage to the landing gear and the lower fuselage of the glider. The pilot was not injured.

Figure 1: Final Aircraft Position at the Accident Site

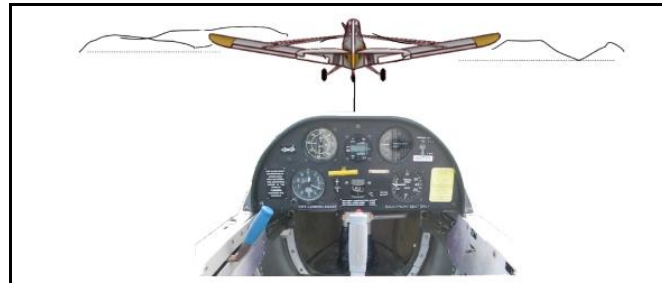
Taking off with open or unlocked airbrakes is a common mistake, often resulting from an incomplete execution of the pre-flight checklist during flight preparation. This procedure is defined in the operational manuals of flight schools as well as in the manufacturer's instructions for gliders. Unsecured airbrakes tend to deploy automatically during acceleration due to aerodynamic forces. Instructions and procedures addressing this issue are specified for both the glider pilot and the towplane pilot. If the airbrakes are open during the takeoff phase, the glider pilot must prioritize maintaining altitude control during the aerotow by monitoring the position of the towplane (as illustrated in the image below).

Figure 2: Visual Contact with the Towplane During Takeoff Phase

*To maintain knowledge and experience in glider operations, a best practice is the periodic implementation of refresher seminars for both powered and glider pilots. For this purpose, the use of AC Celje training material, available at the AC Postojna website:*

*provides an opportunity to refresh theoretical knowledge, enhance awareness of potential critical situations during aerotow operations, and improve decision-making in the event of emergency situations, which in aviation are classified as emergency or abnormal procedures.*
