### NOTICE OF COMPLETION OF INVESTIGATION

#### The accident of the VIRUS 121 ultralight motor aircraft, reg. OE-COR, October 29, 2024, LJNM (Hard landing)

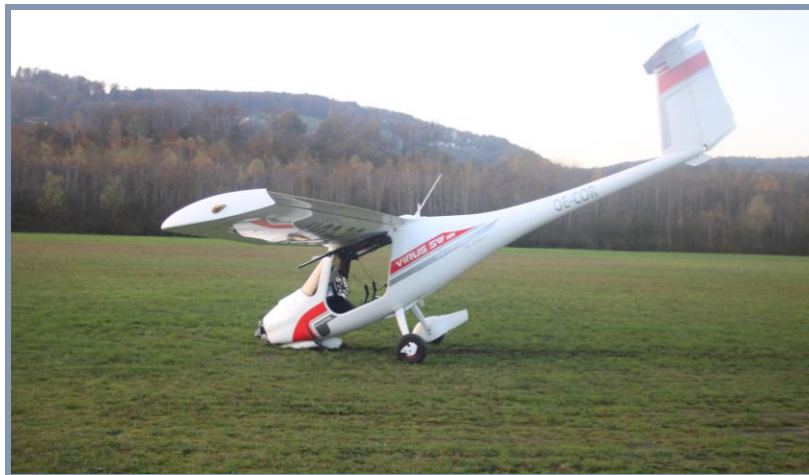
Upon turning final for runway 23, the approach followed the standard landing procedure and was uneventful. In the flare phase, the pilot reported experiencing a southwesterly wind at 5-10 knots. Upon main wheel touchdown, the aircraft bounced and subsequently made a hard landing. Upon contact with the runway surface, the landing gear bounced multiple times, resulting in the structural failure of the nose landing gear, which subsequently led to a propeller strike on the grassy runway surface.

**Slika 1: OE-COR after coming to a stop at the accident site at LJNM airfield**

The event has been categorized as a »hard landing«, which resulted from an unstabilized final approach and delayed aircraft control inputs during the landing phase.
