Maritime Accident and Incident Investigation Services

M/V "NORTHERN VITALITY"

LOSS OF CONTROL WHEN MANOUVERING ON APPROACHES
TO PORT OF KOPER
ON
JANUARY 6, 2015

National occurrence no: 1/2015
EMCIP casualty No: 168/2015

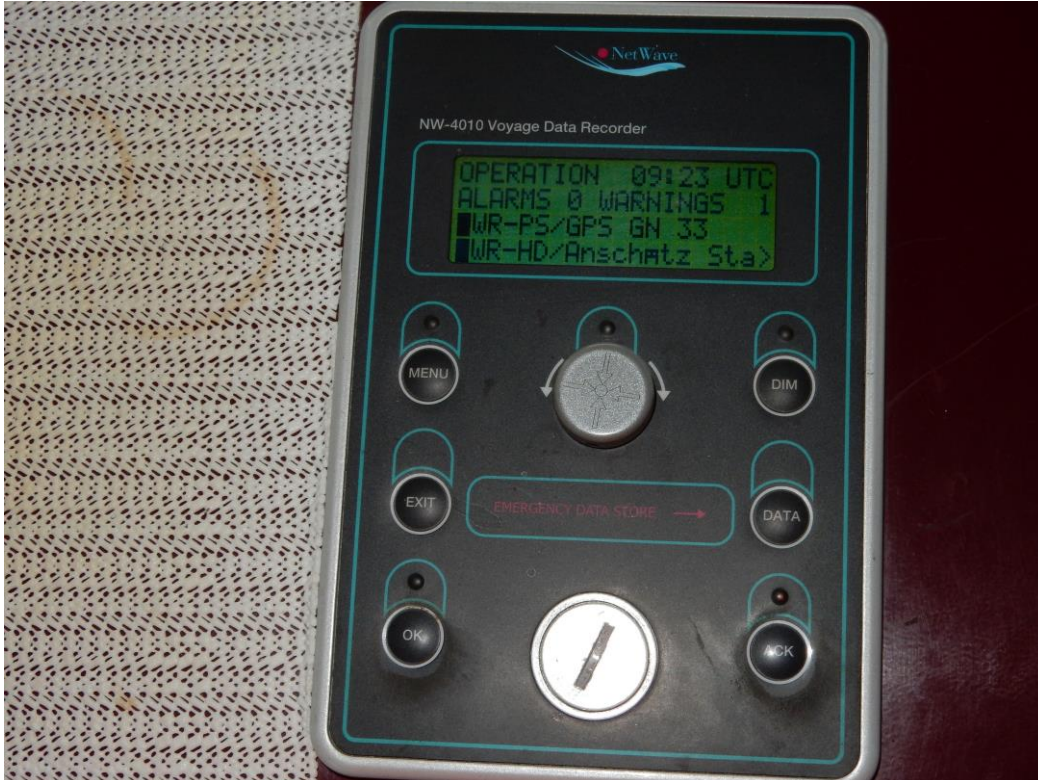
Picture 3: Net-Wave 4010 VDR

'*Northern vitality*' is equipped with NetWave NW-4010 VDR.

1. To ensure that VDR data is available following an incident, the "**DATA**" button on the Bridge Control Unit must be pressed within 12 hours of the start of an incident. (This copies the last 12 hours of data from the protected memory in the capsule to another area of unprotected memory in the base of the capsule where it will not be routinely overwritten).
2. There is only space for one dataset to be saved using the "DATA" button. The system will offer the option to overwrite previously saved data, if the DATA button is pressed again, after an initial dataset has been saved.
3. As standard, the NW-4000 system is not fitted with a hard disk, consequently there will typically only be a minimum of 12 hours' data available in the system.

Incident on board “Northern vitality” happened because of lack of maintenance of the ship’s machinery, not in general, but in this specific case not enough attention was given to air supply system. Also, master did not preserve data on VDR – deliberately or not.

- to instruct masters on their ships to obey requirements of SOLAS convention regarding the proper use of VDR equipment on board the ships to preserve data in case of accidents or incidents;
- to put in place instructions regarding the proper maintenance and regular testing of ship's equipment;
