# SIMPLIFIED REPORT FOR LESS SERIOUS CASUALTY BY THE RO-RO MORNING POST

Drifting from quay in the Port of Koper

AIR, MARITIME AND RAILWAY  
ACCIDENT AND INCIDENT  
INVESTIGATION UNIT

**26. 07. 2023**

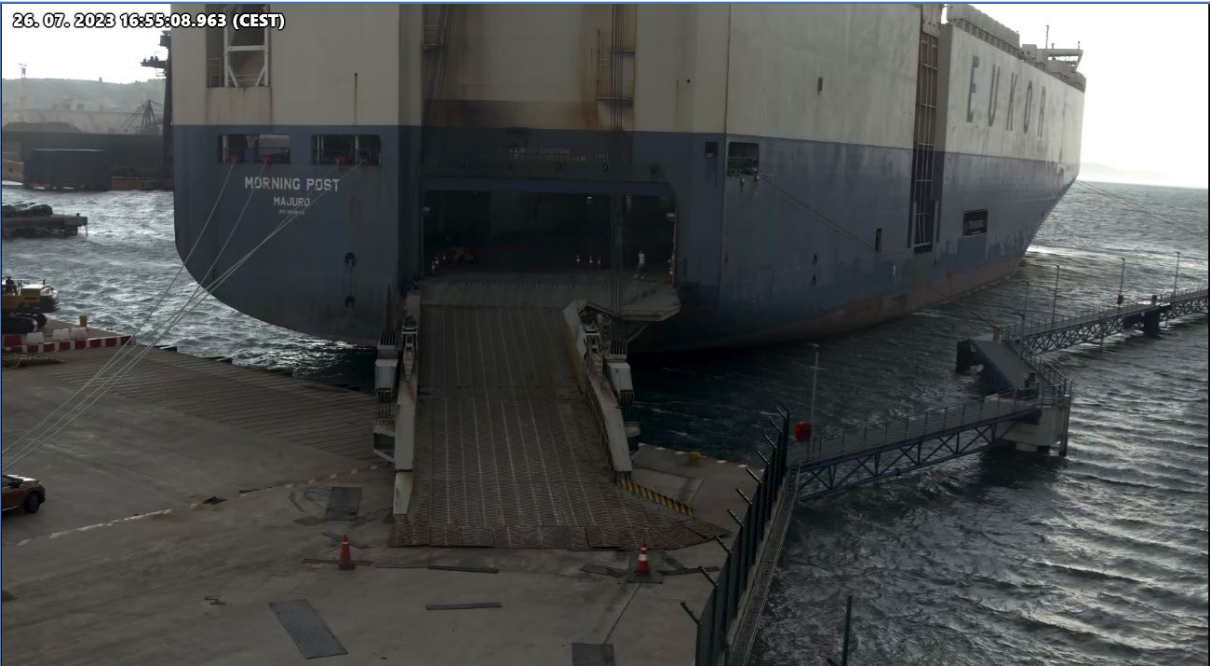
Figure 3: RO-RO MORNING POST, Bow drifting off the pier (VNC)

At 16:51, due to strong winds gusting 25 m/s, the headlines from of the MORNING POST started to slacken. The bow of the vessel continued to move away from the pier.

At 16:55, the vessel's bow was already about 30 meters from off the pier (Figure 3). At this point, one of the headlines broke.

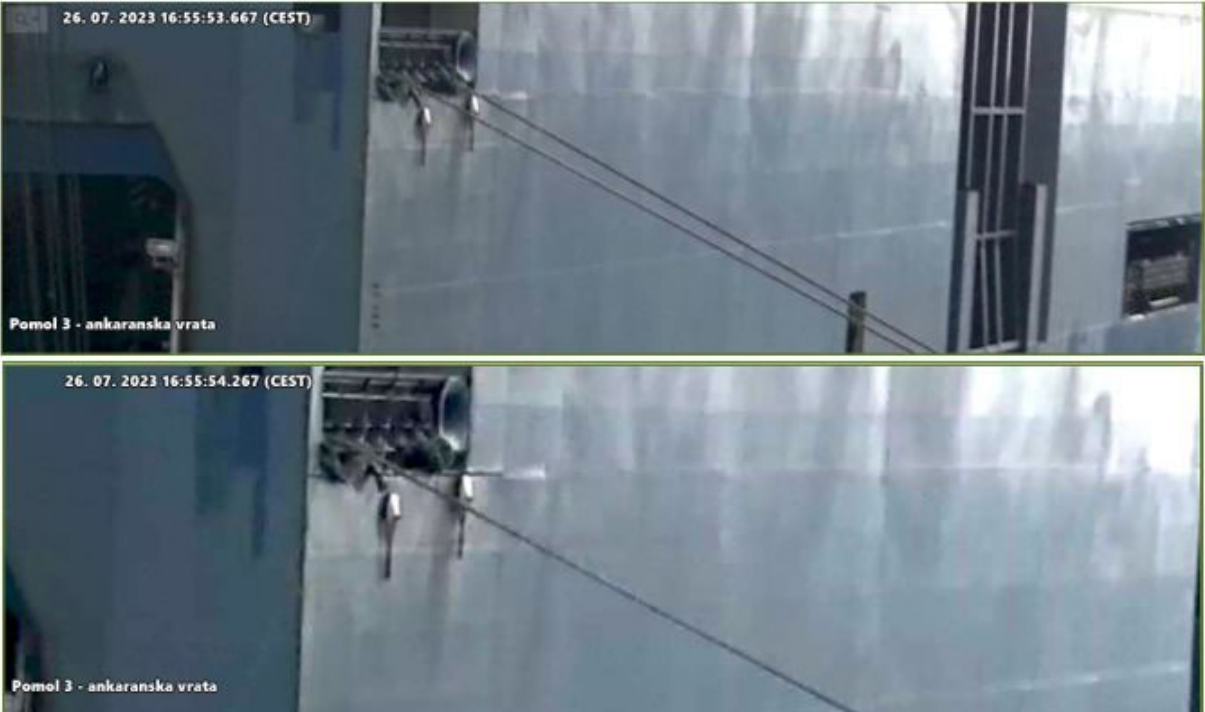
Figure 4: Breaking of the aft spring (VNC)

At 16:55:55 due to combined drifting of bow and stern off the pier, one of the aft springs (forward position) parted (Figure 4).

- At a wind speed of 19.0 m/s gusting to 23.9 m/s, the forward and stern lines began to slacken and simultaneously unwind from the drum of the mooring winches. Two ropes snapped in the process.

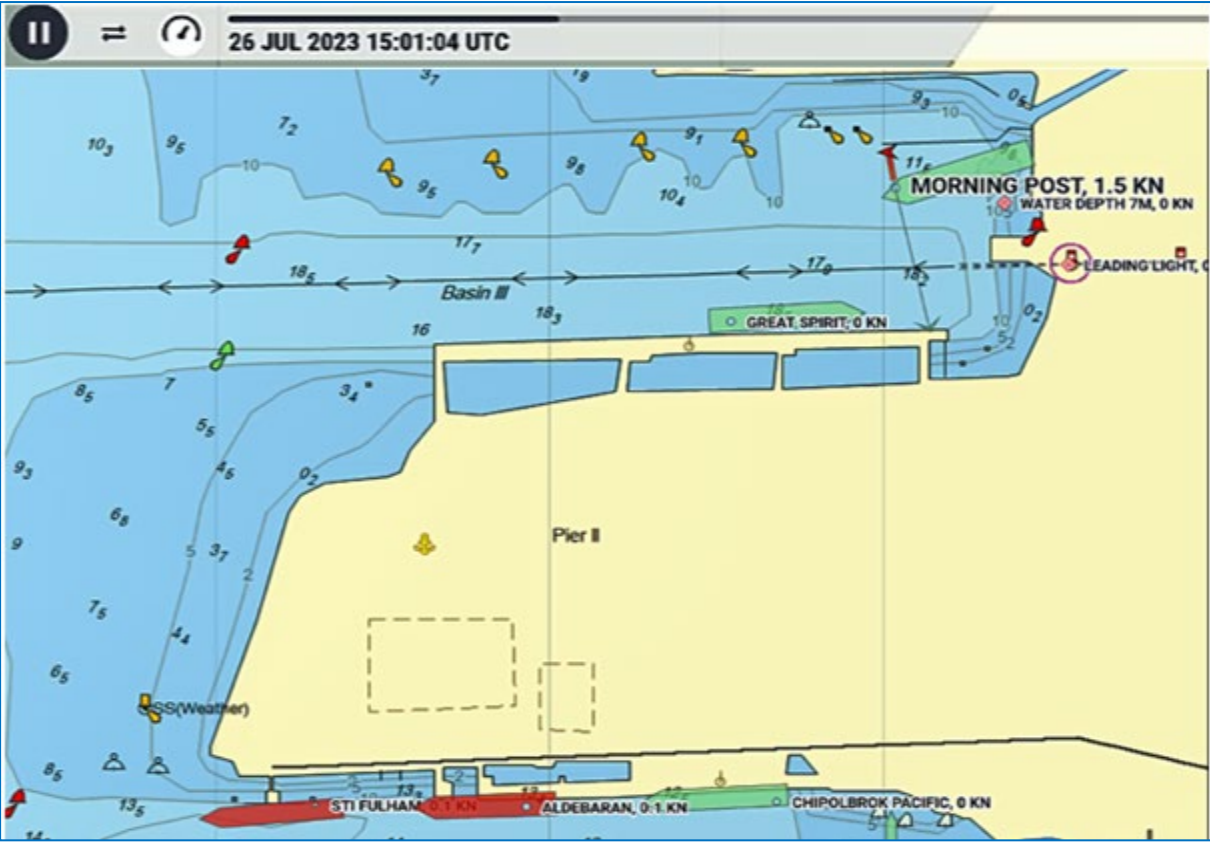
Figure 5: Display of vessel’s drifting from the pier (Marine Traffic)

At approximately 17:01, the bow of the MORNING POST stopped drifting at approximately 60 meters from the pier and the stern moved away approximately 15 meters (Figure 5).

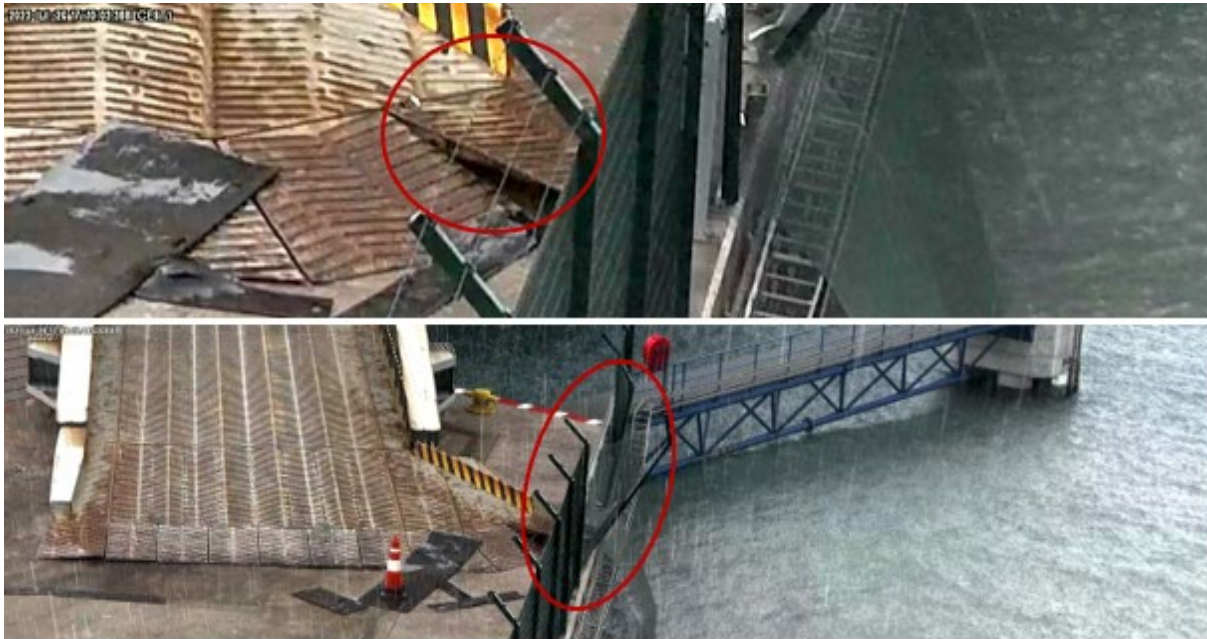
Figure 6: Damaged ramp flap and security fence (VNC)

At approximately 17:06, the ship was again backed up against the quay. In the process, the loading/unloading RO-RO vehicle deck ramp was sliding on the access pier, damaging the pier security and customs fence rail and the ramp’s rightmost flap (Figure 6).

- Due to strong winds, while drifting off the pier, two headlines were damaged (broken) on the bow and one aft spring broken at the stern.
- Damaged loading/unloading RO-RO vehicle deck ramp flap.

- Supporting posts for customs security fence and a panel fence approximately 10 meters long.

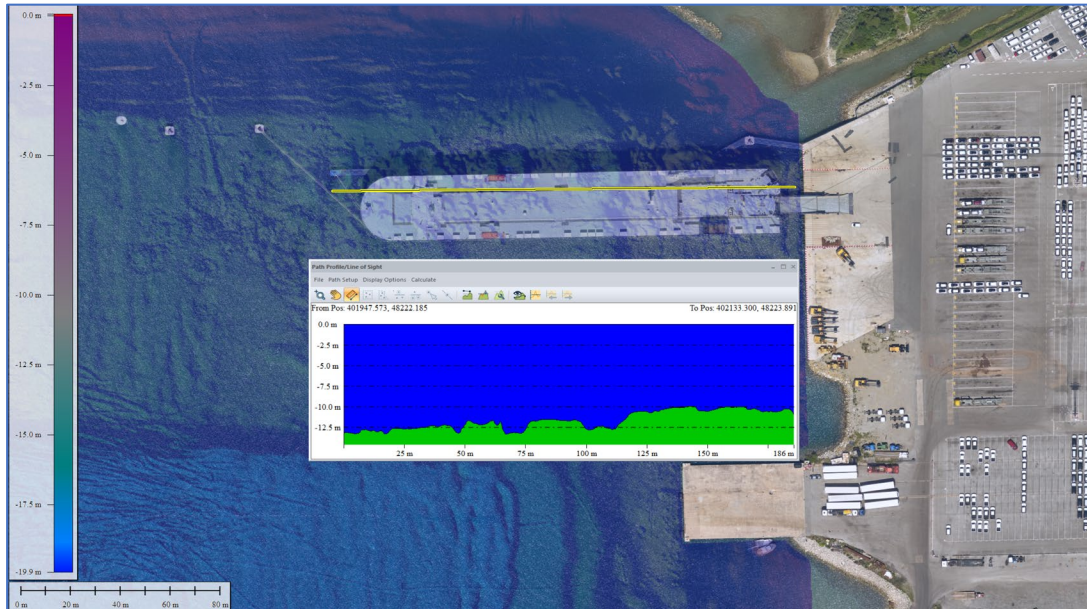
Figure 10: Depths at berth RO4 (Luka Koper)

Mooring depths are in accordance with the project plan.

Figure 10 shows the latest bathymetric measurements along the mooring site; depths along the entire longitudinal profile hydrographically ( $h=-70\text{cm}$ ) exceed the 10 m limit.

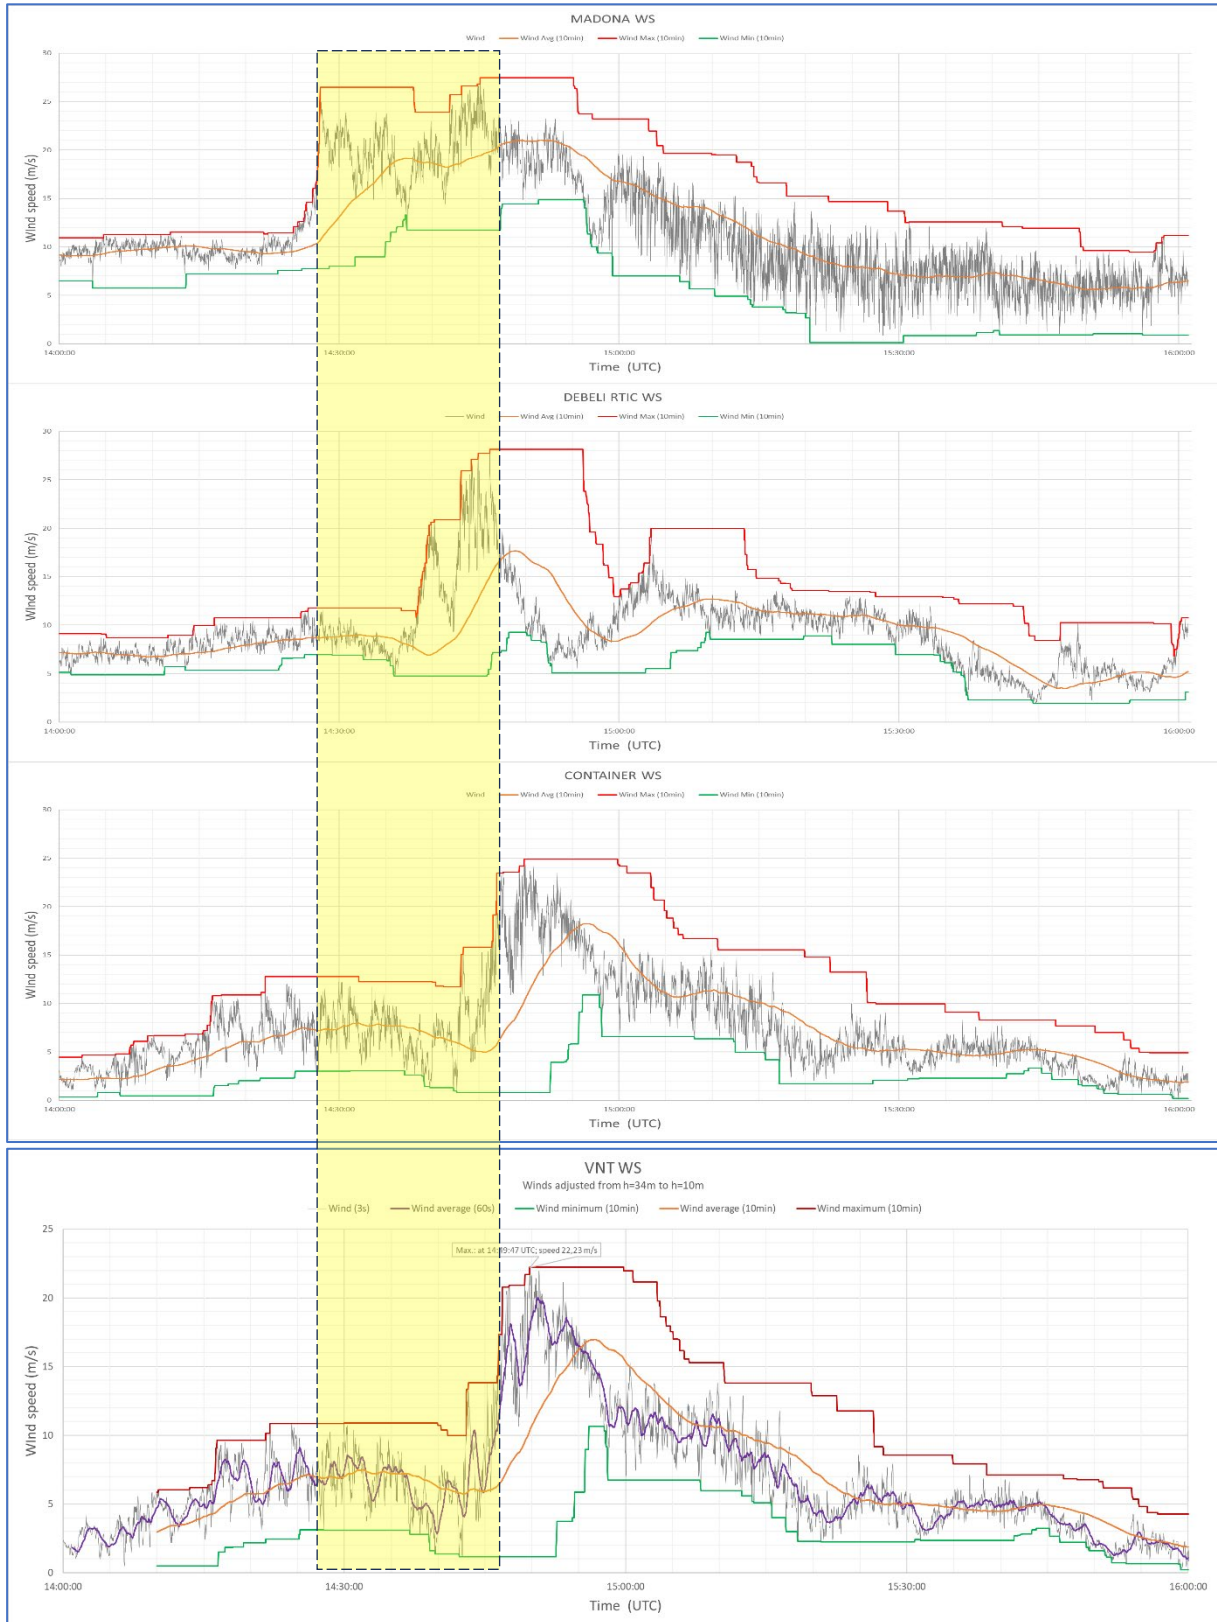
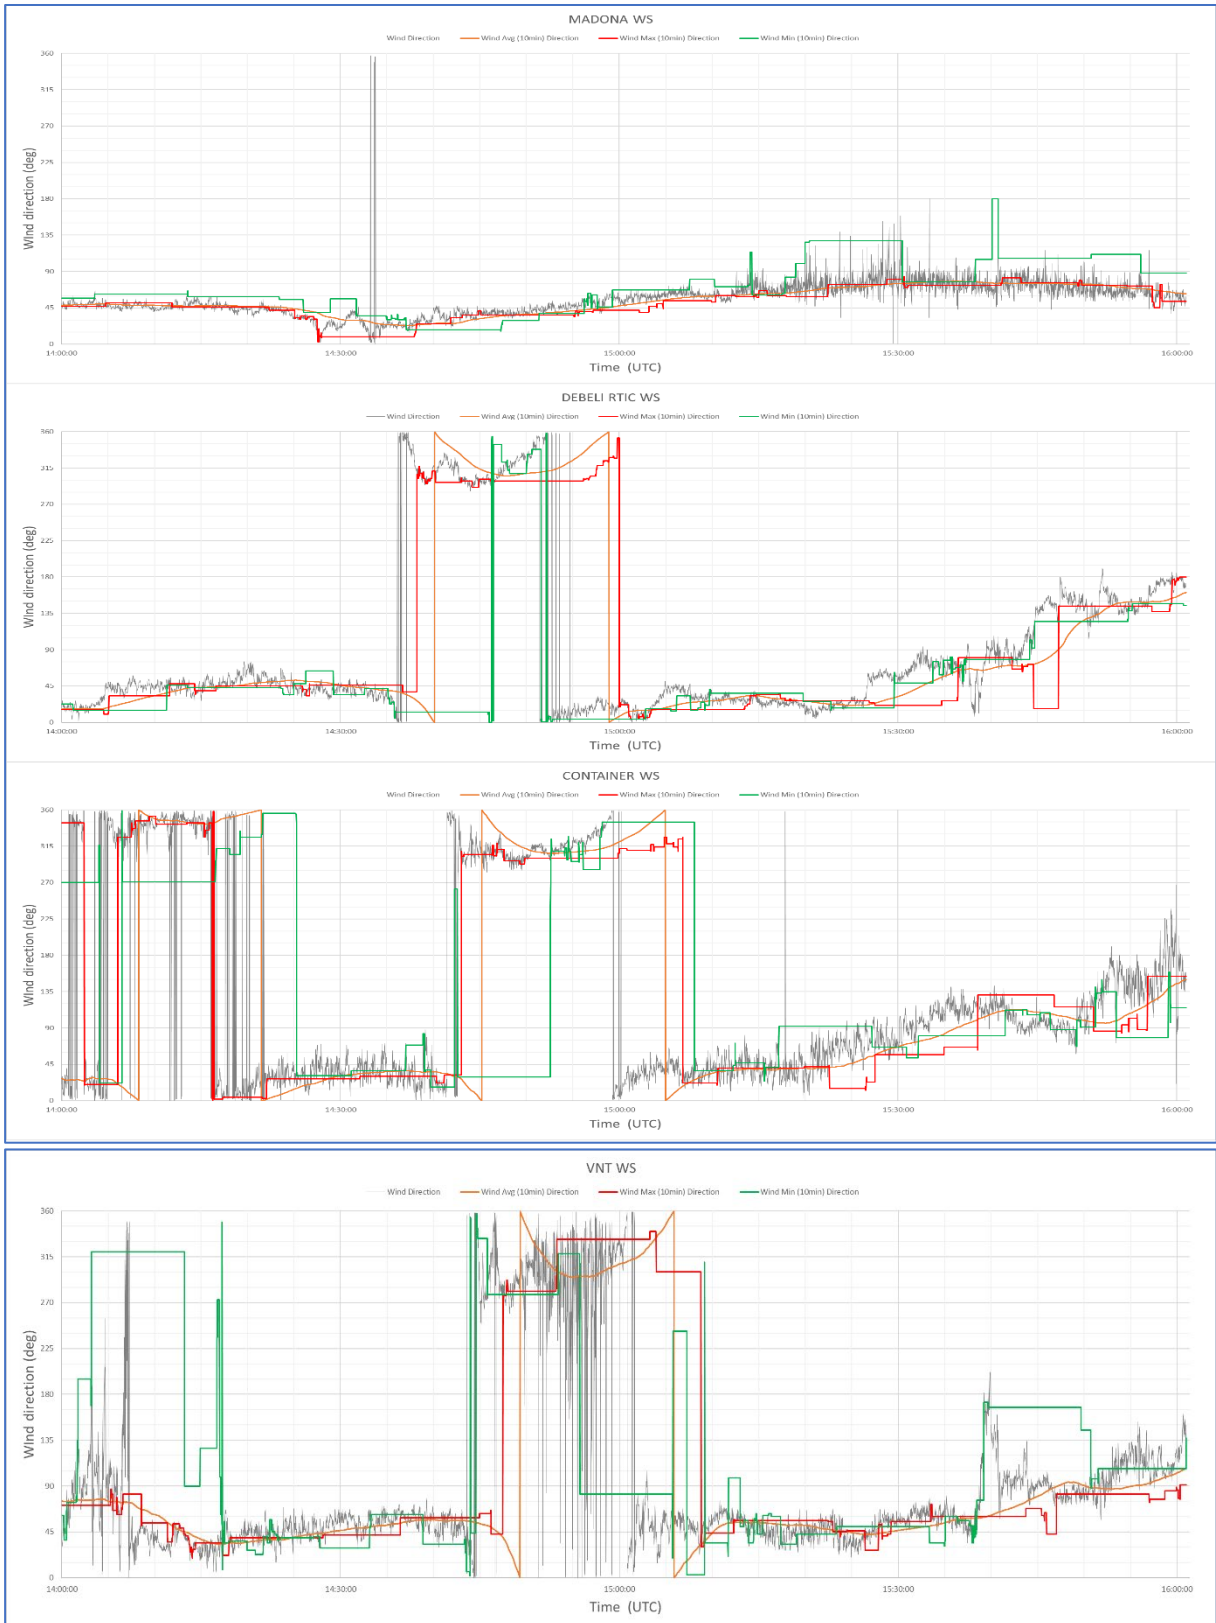
Figures 11 and 12 show the wind direction and speed, and the wind gust direction and speed from the measuring stations at the container terminal of the Port of Koper, Cape Madona, Cape Debele Rtič and the VNT terminal, which is in the immediate vicinity of the Ro4 terminal. The winds are converted to a height of 10 m in UTC notation. The graphs show the values in the time window of the event that occurred on 26 July 2023 between 14:20 and 15:20 UTC.

Winds averaged 7-17 m/s with maximum gusts up to 22.23 m/s from the north (tramontane), daylight visibility was good. Measured wind speeds ranged from 4 to 7 Beauforts (Bf) on the Beaufort scale, while maximum wind gusts were measured up to 9 Bf.

The yellow highlighted banner shows the time window of wind strength when the wind reaches 20 m/s at Madona and later at the VNT terminal, the storm at Madona is detected as much as 20 minutes earlier.

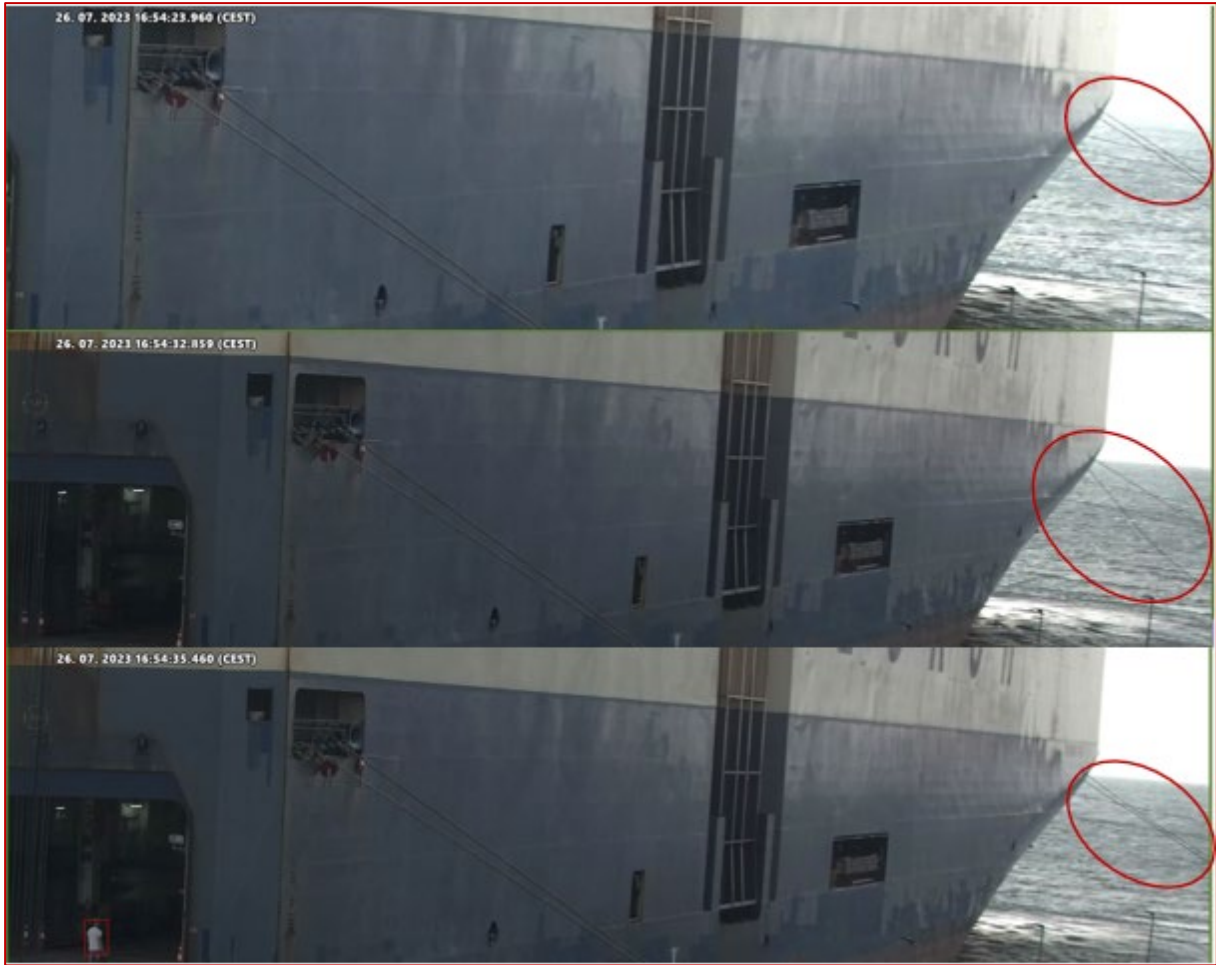
Figure 15: Automatic slackening of the ropes at 16:54:24, 16:54:32, 16:54:35 (VNC)

Figure 15 shows that the ship was using the constant tension facility. The vessel started to move away from the quay at a wind's load caused by wind speed of 19.0 m/s, gusting from 23.9 m/s and a force of 9 Bf, due to the operation of the constant tension facility and automatic slackening of the ropes on all mooring winches. Surveillance camera footage shows that on several occasions the ropes automatically slackened as the mooring was moving away from the shore. Two of the ropes snapped. **Safety Recommendation 1.1 follows from point 1.**

1.1. It is recommended that in the event of expected bad weather, mooring lines on winches should be secured with brakes and that the constant tension facility should not be used. If the Safety & Quality Manual does not mention such procedures, it is recommended that it shall be updated.
