# SIMPLIFIED REPORT FOR MARINE INCIDENT BY THE M/V XIN BEIJING

Breakaway from quay in the Port of Koper  
26. 07. 2023

Izola, 31. 12. 2023

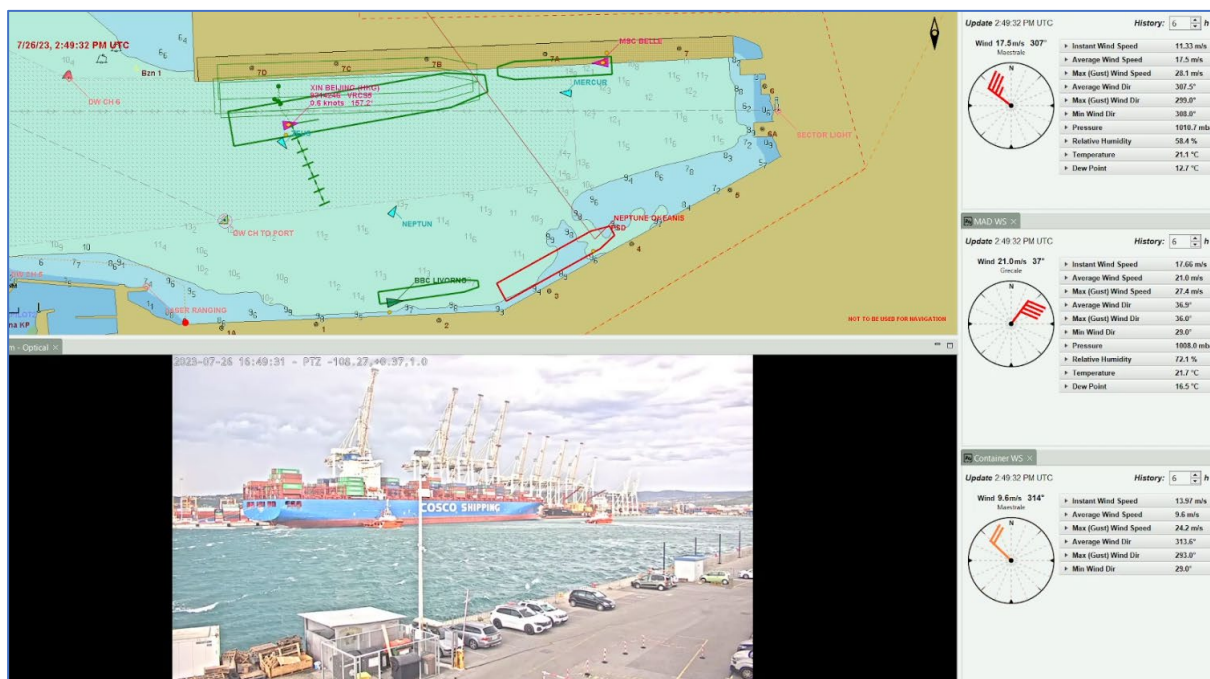
Figure 2: 16:49:32; Xin Beijing - aft springs breaking and stern lines slackening (Source: SMA)

At 16:44:35, the Xin Beijing requested tugs assistance. Tug Zeus started to assist by pushing the stern at 16:48:29, but its assistance was not sufficient in such weather conditions. The wind was 27,4 m/s blowing from 0370. The stern breast lines were very tight. At this point the brakes on the drum of the mooring winches must have started to give way. The ship's heading has started to decline and at the same time, longitudinal movement of the BSC Belle at berth 7A was also observed. At 16:49:51 the first forward spring on the Xin Beijing broke (Figure 3).

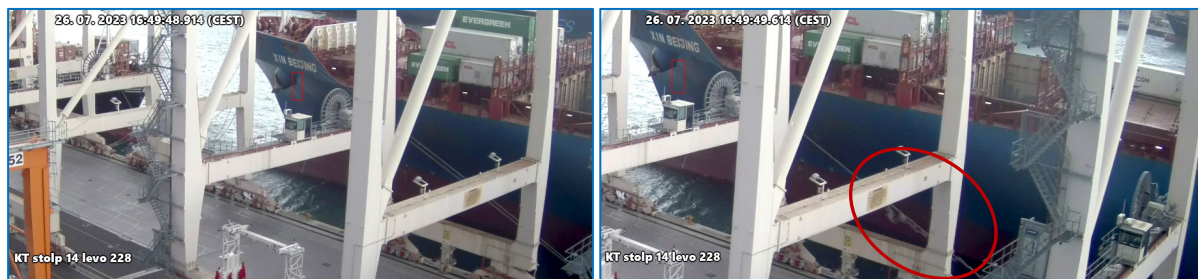
Figure 3: Situation at 16:49:51; breaking of the forward spring on the Xin Beijing (Source: VNC)

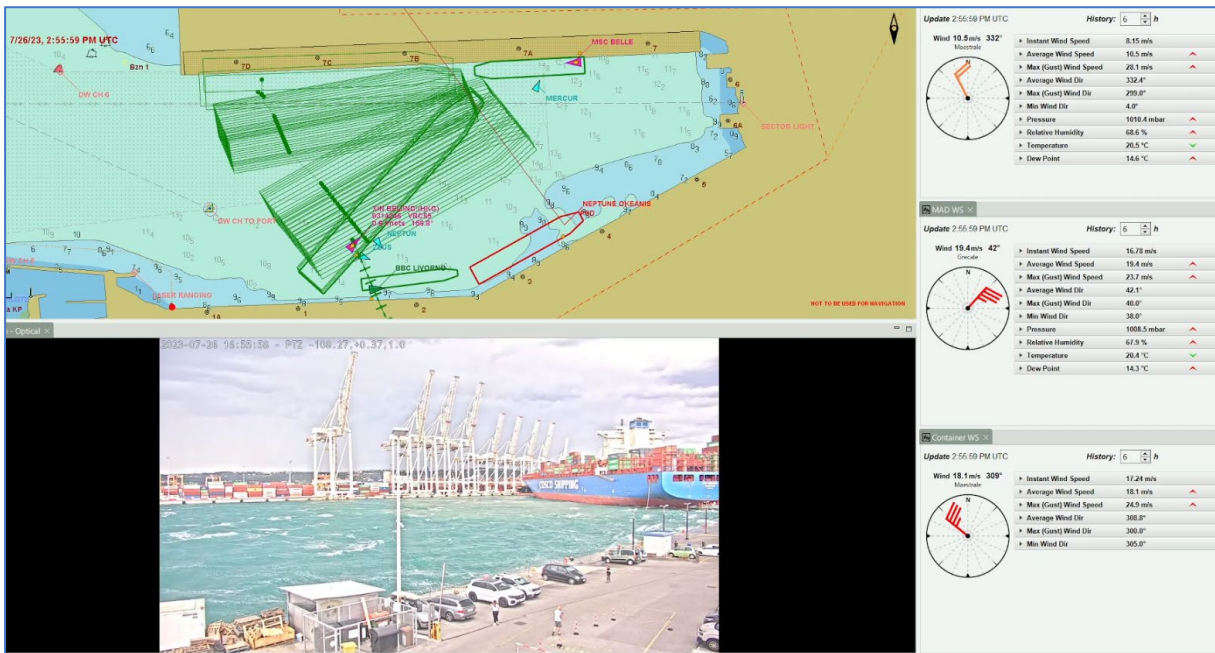
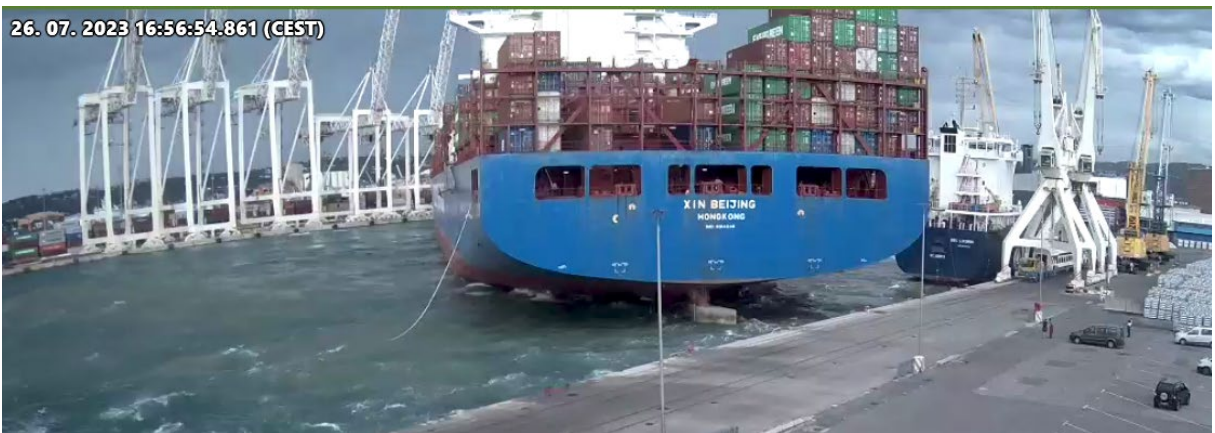
expressed concern for the safety of his vessel. The Xin Beijing's mooring lines, except for the forward springs, are still in place. At 16:55 it was clear that the tugs Zeus and Neptune would not be able to resolve the situation on their own, so the tug Mercur, which had been pushing the MCS Belle in a stable condition up to that point, joined them. The ship also used the rudder and main engine to stop further approach to the BBC Livorno (Figures 4 and 5).

Figure 4: : Situation at 16:55:59; the Xin Beijing has completely closed Basin I (Source: CNP)

Figure 5: Xin Beijing close to the BBC Livorno (Source: VNC)

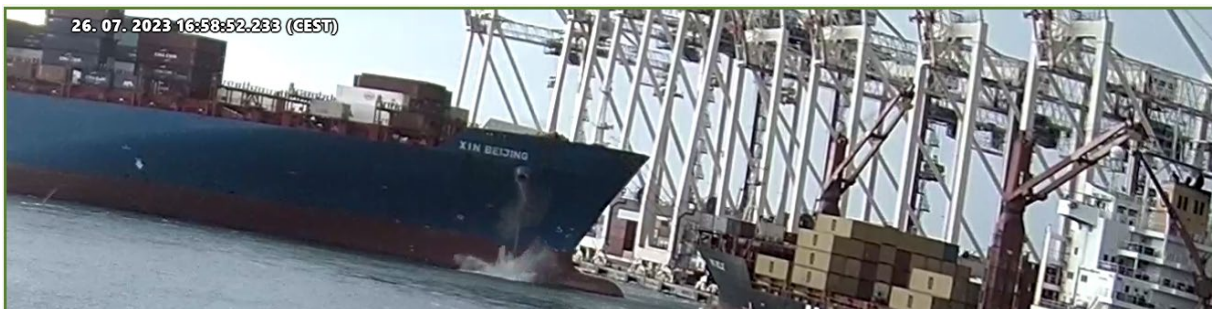
The Xin Beijing was ordered by the CNP (SMA) at 16:54:22 and again at 16:57:58 to drop starboard anchor. The Xin Beijing only dropped anchor at 16:58:52 (Figure 6). The northerly wind gusts were still reaching 23.9 m/s. The BBC Livorno was no longer endangered.

Figure 6: 16:58:52, Xin Beijing dropped starboard anchor "Source VNC)

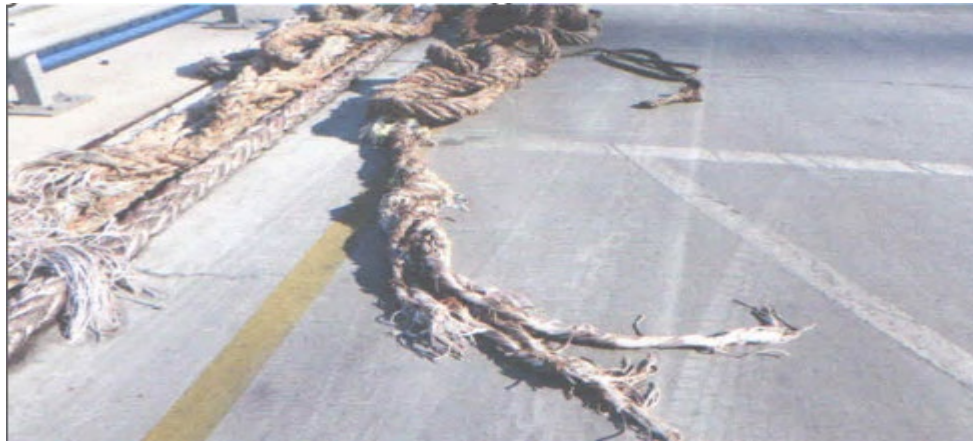
- Due to the strong winds, the ship's mooring lines, six in total snapped, of which two forward springs, two aft springs and two stern lines.
- No other damages occurred on the vessel, other vessel(s) or port infrastructure.

Figure 8: Damaged ropes, two types of ropes present

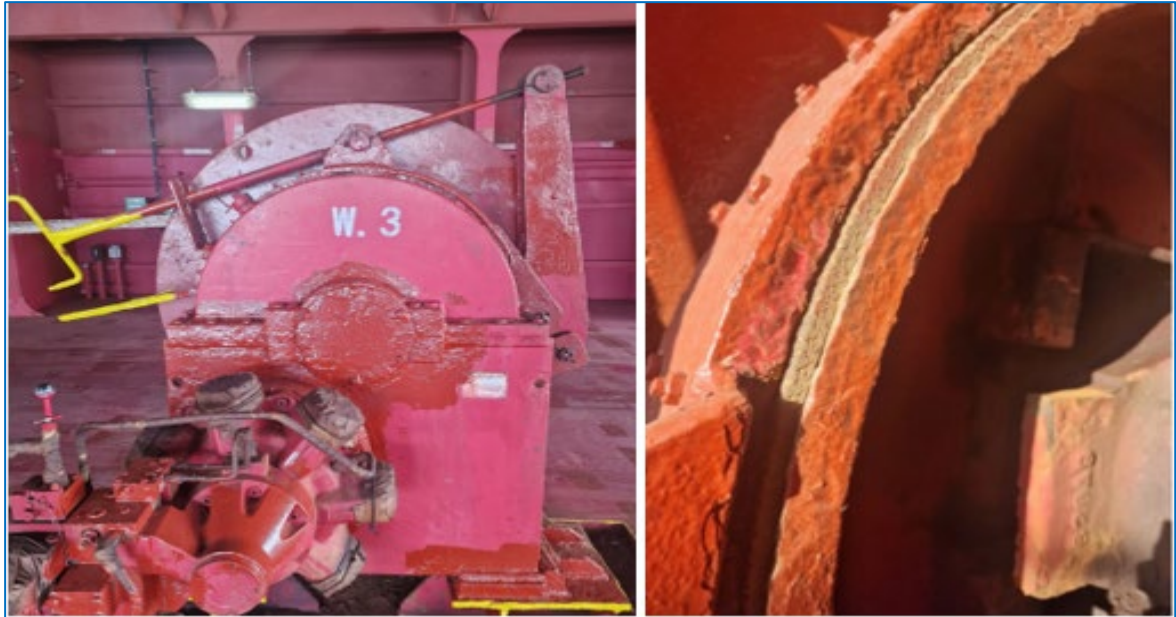
At 16:49:32 the forward springs and stern springs of Xin Beijing broke due to a 27,4 m/s gust from direction of 037°. At this point, most probably the aft winch brakes started to fail, and the ship's stern started uncontrollable moving. On the next arrival of the ship (end of September 2023), all winches were found to be renewed and all brake linings had been replaced.

Figure 16: Stern winch and renewed brake linings (Sep. 2023)

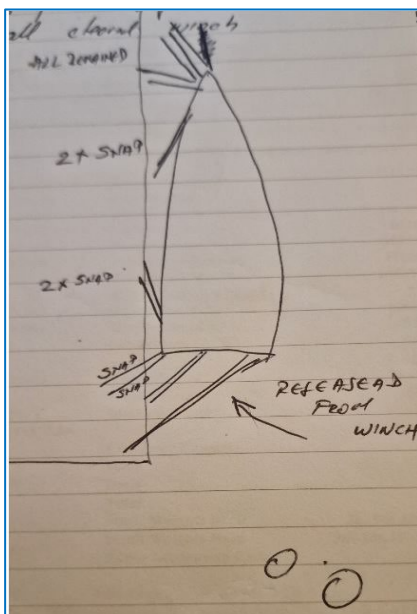
The ship did not use floating mooring devices at the berth, Figure 17 below right shows the mooring of the same ship on the next arrival. The springs were too short, making them steep, i.e., the large vertical angles of the ropes do not provide longitudinal stability of the mooring.

Figure 17: Mooring sketch

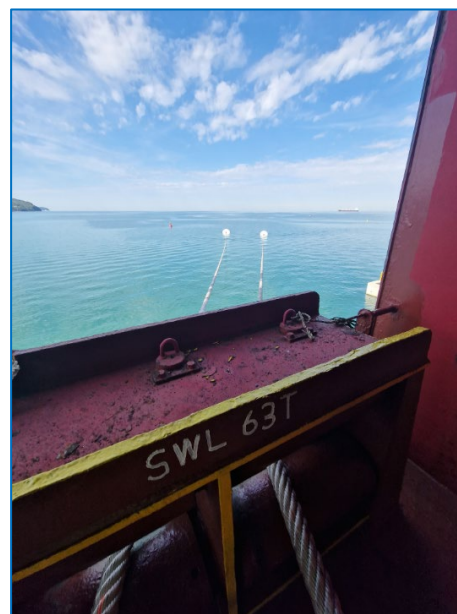
Figure 18: Use of floating devices (buoys)
