FINAL REPORT FOR SERIOUS CASUALTY ON M/V G TAISHAN

Personal injury of port worker during steel coils
discharging in Port of Koper, berth 11, Basin II
18. 05. 2024

18. 05. 2024

Marine Accident and Incident Investigator

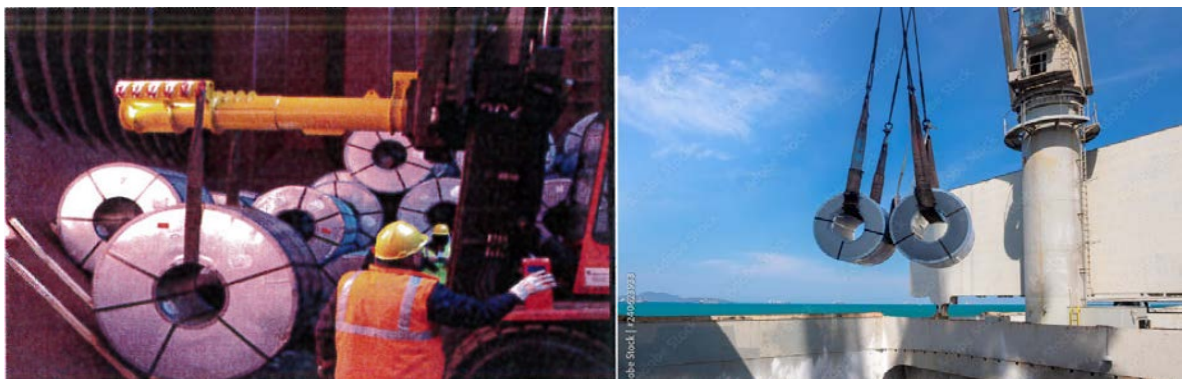
The handling of the steel coils continued from the shore side of the hold through the hold opening (wing). The steel coils stacked at the far edge of the hold were strapped using synthetic slings and attached to the ram attachment on the forklift. The forklift then moved the coils to the open part of the hold from where the shore crane transferred them onto the shore. There were approximately twelve coils in this batch (Figure 5).

Figure 5: Depiction of Handling in the Ship's Hold and Transfer of Coils to the Shore with a Crane

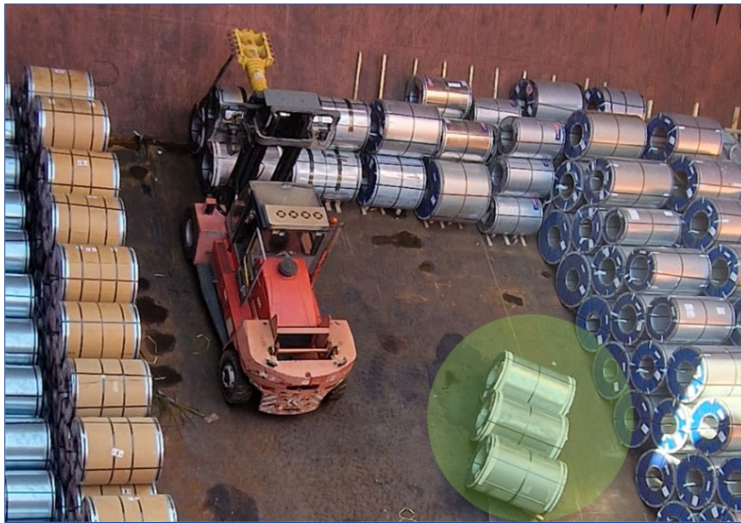
Figure 6: Depiction of the hold's layout as it was before the incident

Once the remaining cargo from the portside (shore) side of the hold was unloaded, work began on unloading the remaining steel coils from the starboard (sea) side of the hold. Prior to the incident, three pieces of steel coils were manipulated and prepared in the center of the hold for lifting onto the shore (see Figure 6). Before starting the manipulation of the next steel coil, the first one in the second row from the bow, PTW M. K. moved to the left side of the

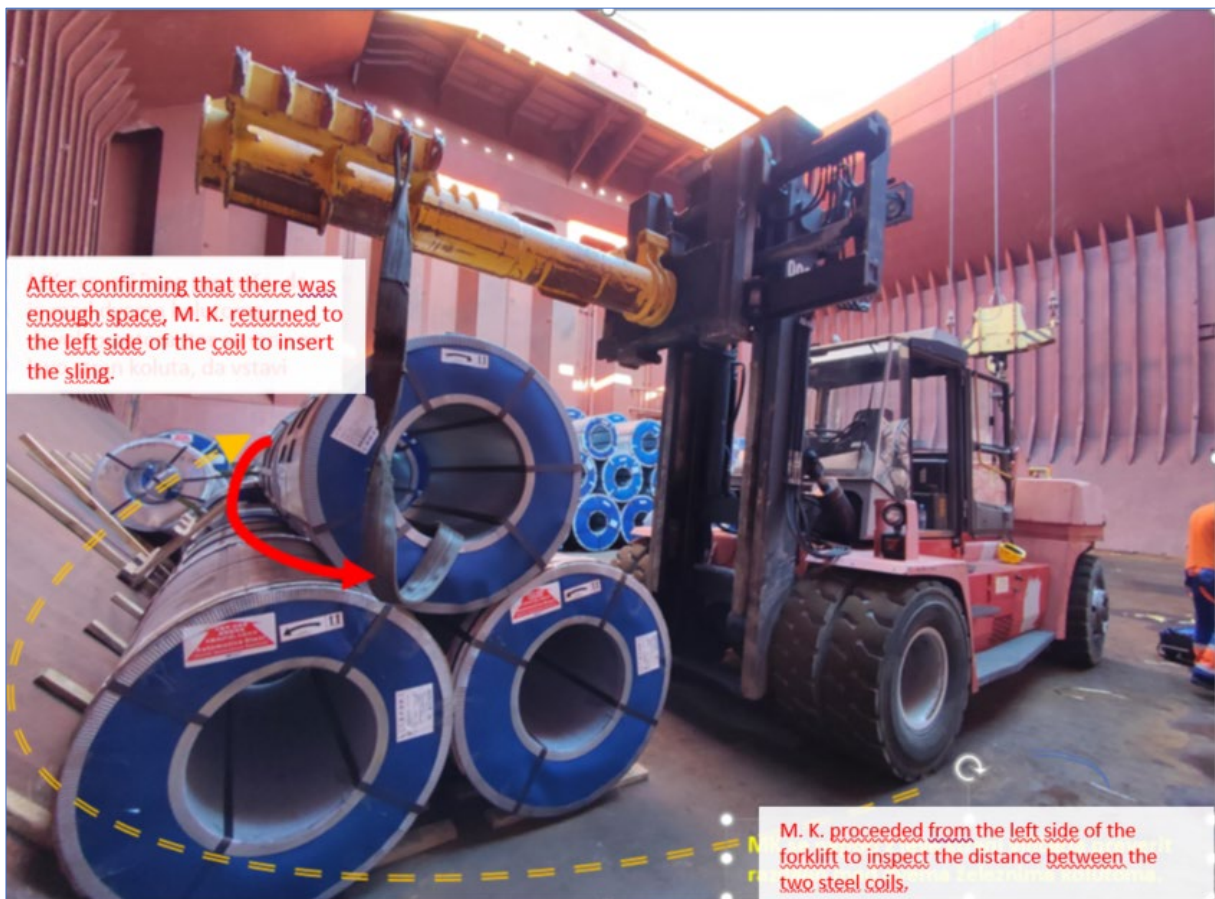
Figure 7: Movement of the injured person, M. K., before the injury

While unloading the remaining cargo from the right (sea) side of the hold, PTW M. K. climbed onto the first row of coils and proceeded to the space between two coils (see Figure 7, yellow line). After confirming that there was enough space between the two coils for the synthetic sling to move freely and that no additional equipment (steel wire) was needed, M. K. returned to the left side of the coil (towards the bow) to prepare the sling for securing the coil (see Figure 7, red line).

To prevent slipping off the coil in the first row, M. K. slightly leaned forward towards the bow while in a crouched position and supported himself with his left hand on a coil in the second row. Shortly thereafter, he experienced severe pain in his left hand because the forklift operator had lowered the ram attachment onto the coil, pinching M. K.'s hand.

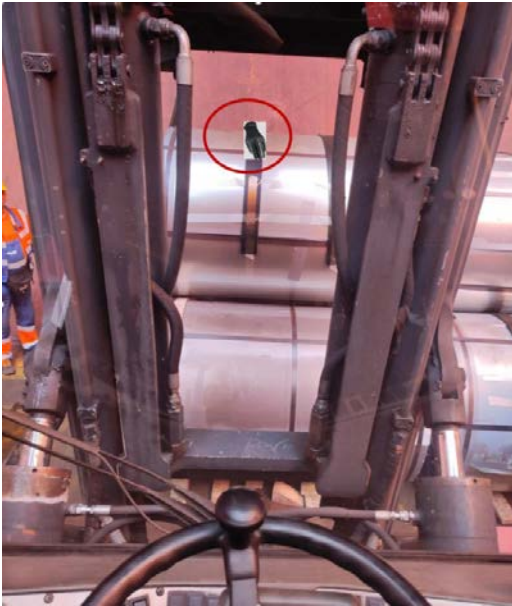
Forklift Operation: The forklift operator lowered the ram onto the coil, which compressed M. K.’s left wrist and forearm. According to standard procedures, the ram should be lowered slightly and stopped above the coil to prevent damage to the cargo. On this occasion, the driver lowered the ram onto the coil for an unknown reason.

Forklift Operator's Statement: Forklift operator P. V. mentioned that the injured worker was in the "dead angle" and was not visible to him. Figure 8 below shows a probable position of the injured worker's arm. If the ram was raised (as shown in the figure), the arm would be visible to the operator. If the ram was somewhat lowered, it is questionable whether the operator could have seen the injured worker or his hand on the coil.

Figure 8: probable position of the worker's arm relative to the ram and the forklift operator.
