FINAL REPORT

ON LESS SERIOUS CASUALTY

on m/v MINOAS IMO No. 9519315

**Personal injury of port worker during
steel pipes discharging in the Port of Koper
27. 10. 2024**

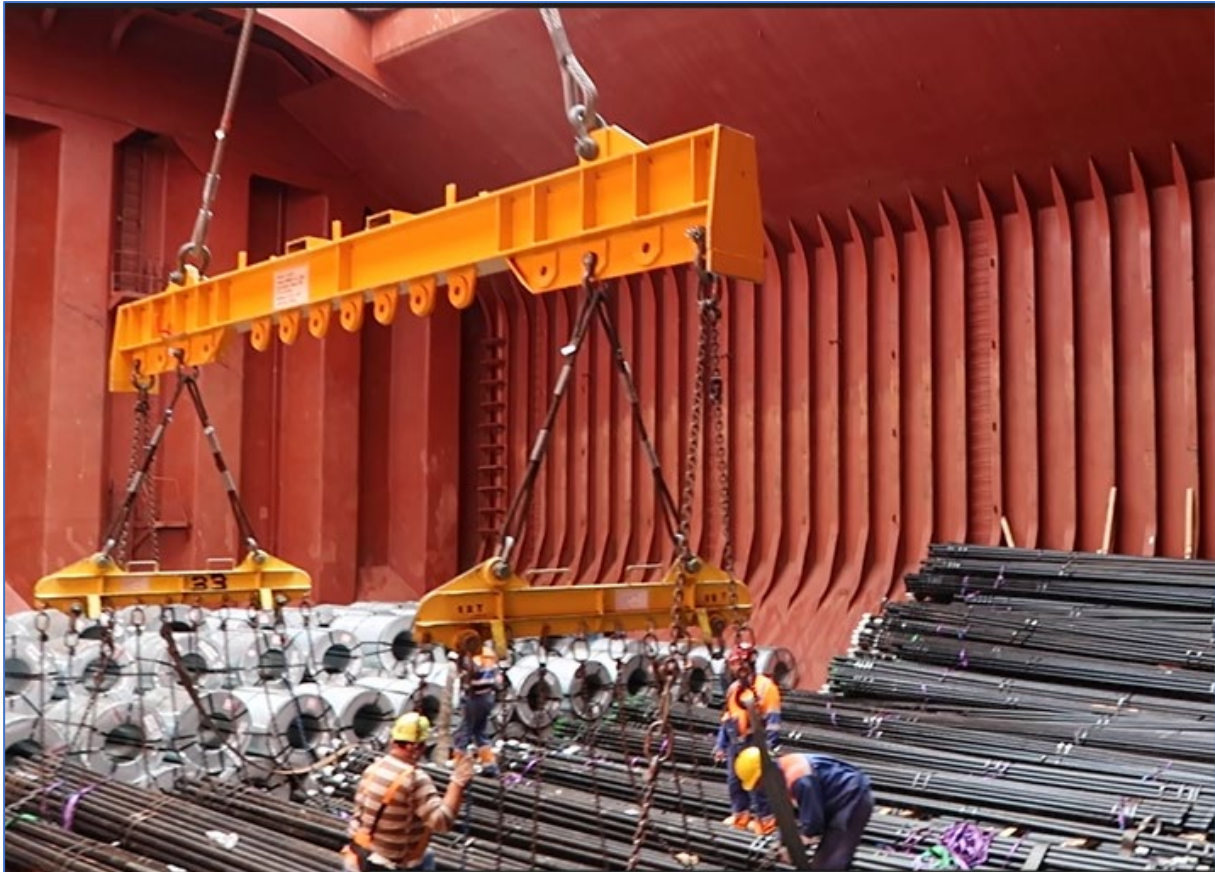
Figure 3: Pipes discharging using lifting beam

Morning shift started discharging steel pipes in bundles from hold no. 4 at 0600 hours, by means of cargo lifting beam and shore crane. There were 5 port workers presented in the hold during the discharging. Those were supervisor, signaller and four dock workers (port handling workers). About 8-10 bundles of steel pipes were lifted at the time (see figure 3).

The cargo was equipped with lifting wires (rope slings), which were used for loading at the previous port. However, these lifting wires are misaligned and not properly centered, and due to prior use, they have become stretched. Additionally, it is unclear whether the wires are damaged. As a result, the lifting wires are deemed unsuitable for lifting the cargo from the ship's hold.

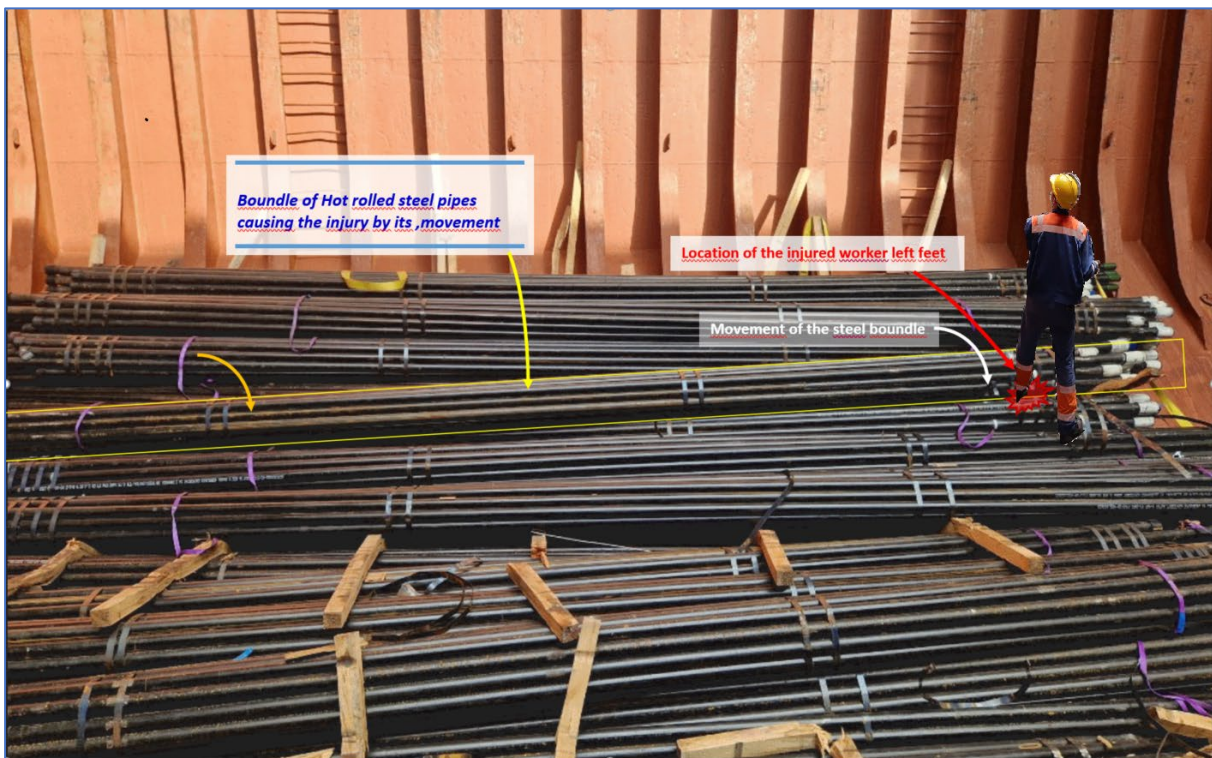
Figure 4: Situation in the hold at the time of injury - Simulation

- The injured worker, O. N., was the first to move and was positioned about one meter ahead of the nearest colleague.
- At the time of the injury, an uncontrolled shift occurred with one of the pipe bundles, which shifted directly in front of O. N.'s legs. On the aft side, the bundle became caught on another pipe bundle (indicated by the orange arrow), while on the opposite side (indicated by the white arrow), the bundle rolled and applied pressure to O. N.'s left ankle (see Figure 4).

- Accidental event: ✓ **Uncontrolled Shifting and Movement of Pipe Bundles –** Accidental event was caused by uncontrolled shift and movement of one of the pipe bundles during cargo handling.

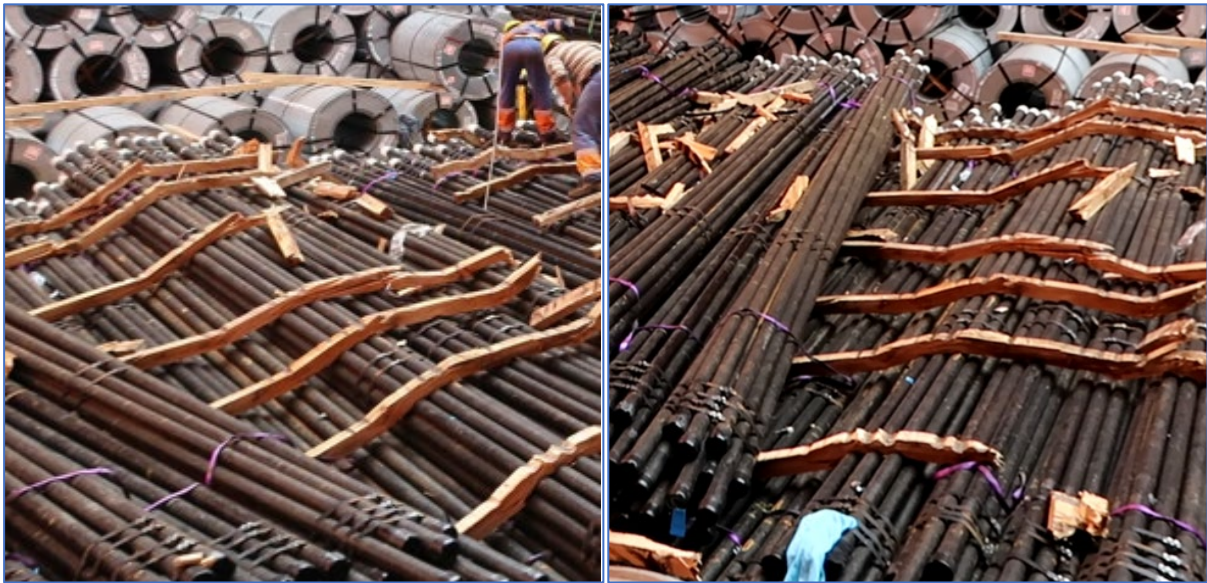
Figure 5: Lining material between bundles

- Cargo (pipes) was stowed using the wooden linings. Due to (presumably) uneven stowage of bundles, almost all wooden linings were deformed and/or destroyed (Figure 5).

- ✓ **Damaged Wooden Linings:** The wooden linings supporting the cargo were either deformed or destroyed, compromising their structural integrity or further destabilizing the load.

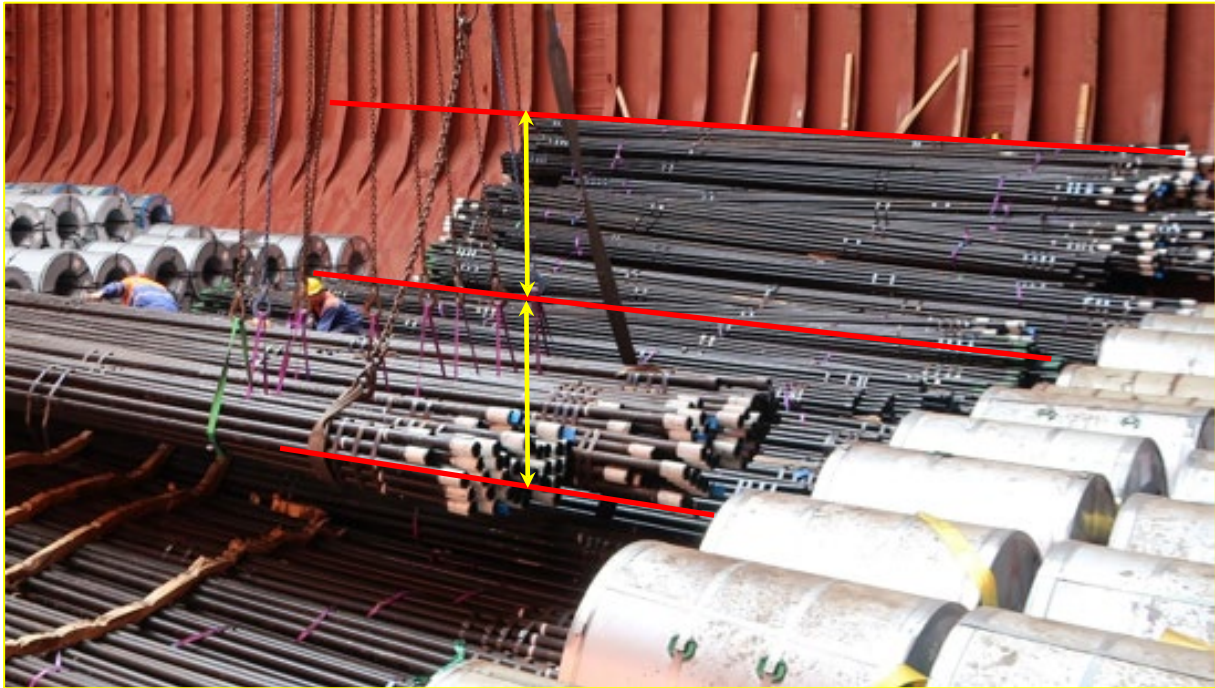
Figure 6: Uneven distribution of cargo following discharging from the middle of the hold

- The cargo (bundles of pipes) was discharged in a manner that most of the bundles were removed from the central part of the hold, resulting in an uneven distribution of height at both ends of the hold (Figure 6).

- ✓ **Improper Cargo Discharge Procedure:** Discharging cargo primarily from the central area of the hold resulted in an uneven distribution of load height at both ends of the hold. This imbalance significantly increased the risk of uncontrolled shifting of the cargo, potentially leading to hazardous situations.

It is recommended to ensure strict adherence to safety guidelines that is essential for cargo handling operations. Specifically:

- To follow Safety Protocols by ensuring compliance with TP: 10 002 0 TECHNOLOGY – Handling of Steel Bars, Tubes, and Profiles, Section 6, regarding cargo collapse hazards.
- Training and Awareness: Reinforce safe unloading practices, particularly limiting digging between cargoes to a maximum depth of human height.
- Enhanced Supervision: Increase oversight during unloading operations to prevent instability and reduce risks of accidents or injuries.
