FINAL REPORT FOR SERIOUS CASUALTY ON RO-RO VESSEL SEA PATRIS

Personal Injury during vehicles transshipment

Port of Koper, berth RO4

06. 03. 2024

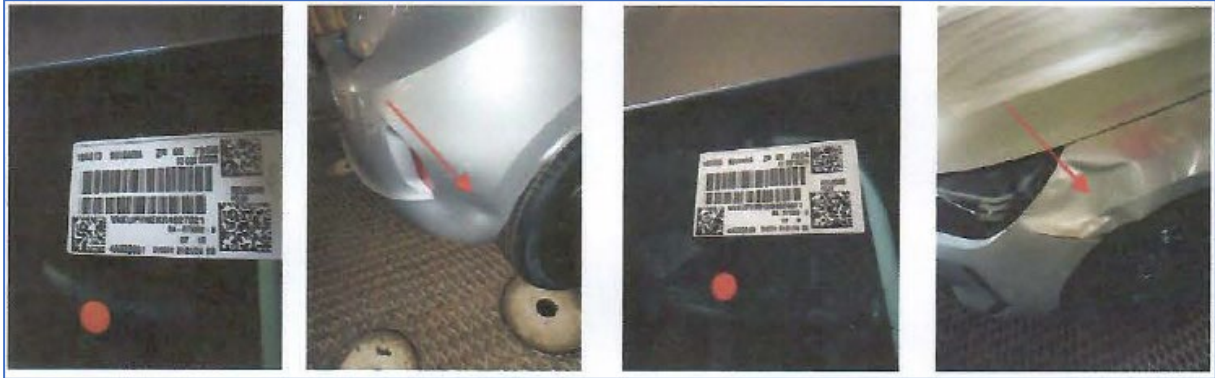
- Vehicle "A" Opel Corsa VIN No VVKUPHNEKR4027021: rear bumper dented, right rear bumper dented.
- Vehicle 'B' Opel Corsa VIN No VVKUPMHDR4026971: dents on left front bumper, headlamp (left side) scratched, front bumper (bottom) smashed, front bumper scratched.

Figure 2: Damages on vehicles I (source: Sea Patris)

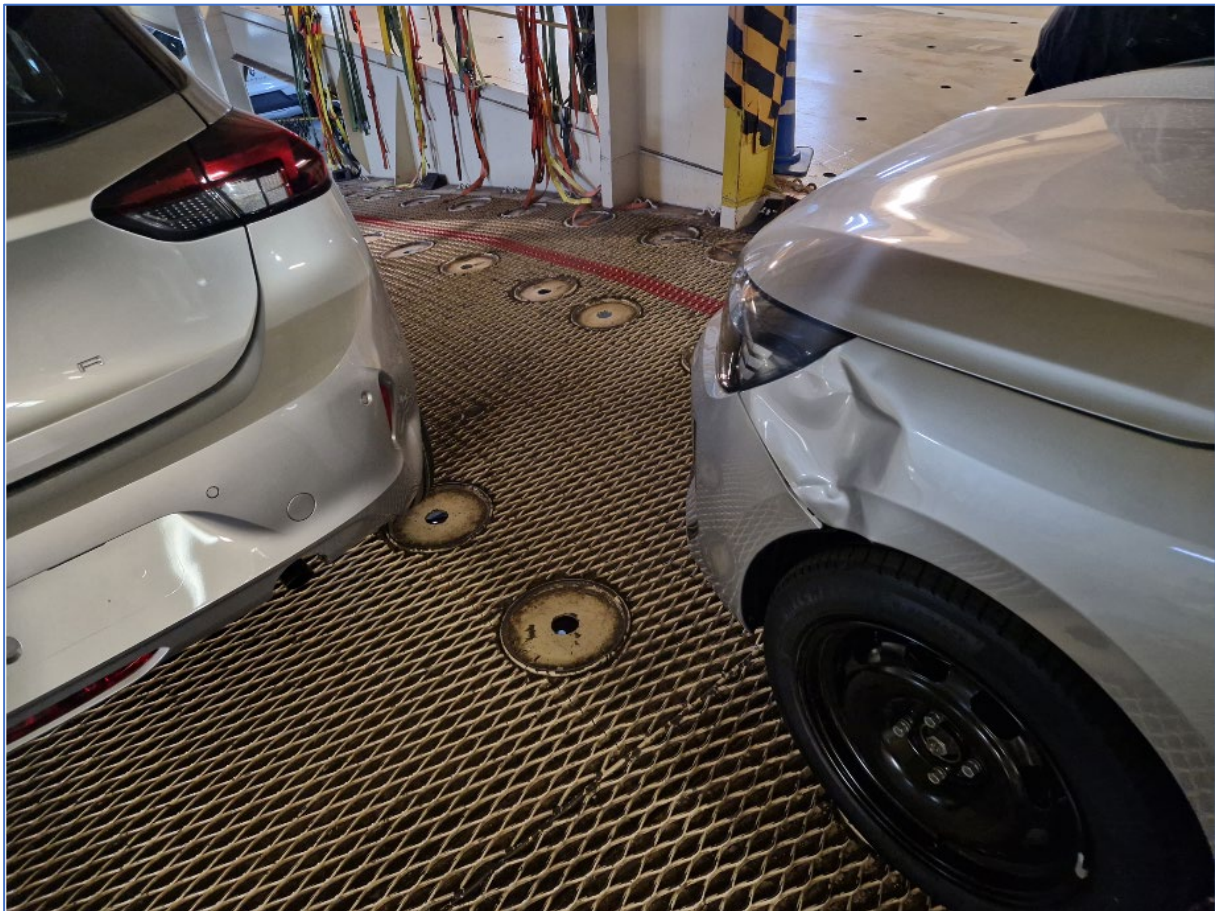
Figure 3: Damages on vehicles II (source: VNC Luka Koper)

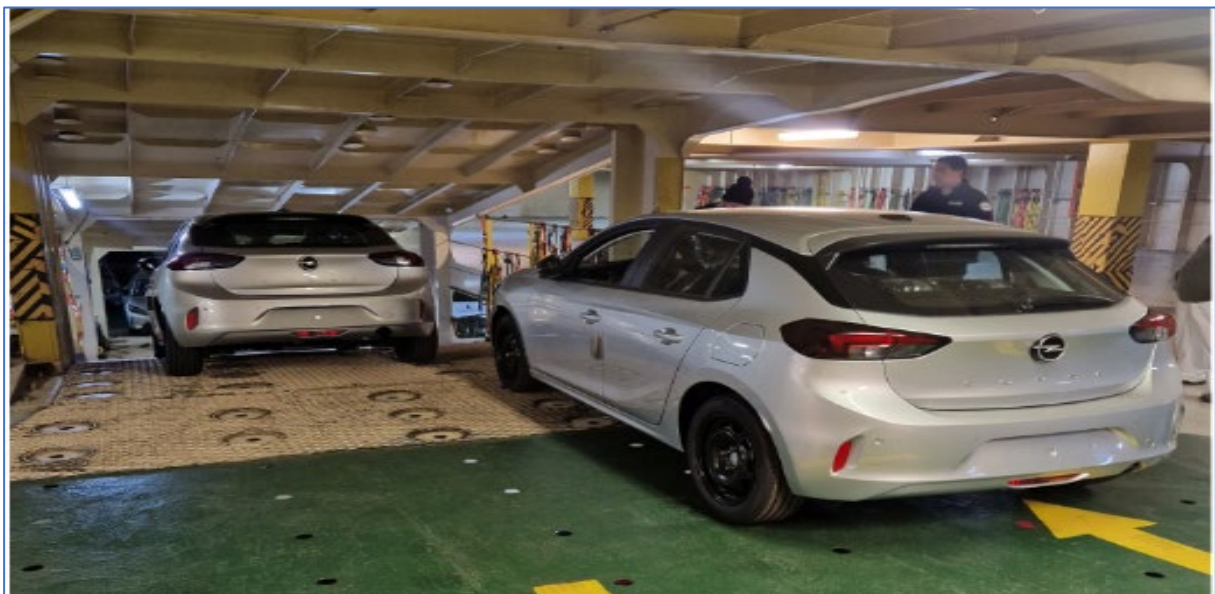
- Vehicle "B" was on the ramp and could not start at that moment. The drivers present pushed vehicle 'B' up the ramp and stopped it on the flat part of the ramp to make room for the smooth passage of vehicles from deck 3 to deck 4 towards the upper decks and the unloading ramp at the ship's exit (Figure 6).

Figure 6: Position of the stationary vehicle "B"(source: VNC Luka Koper)

- 3.1. When the unloading of vehicles from hold 3 started, two vehicles were positioned on the ramp between the decks for unloading.
- 3.2. Vehicle "B" could not start in time due to engine failure. It was therefore decided by the Group's duty signalman to push the vehicle up the ramp and to move it to one side, thus freeing up space for the smooth passage of vehicles from Deck 3 to Deck 4 towards the upper decks and the ship's unloading ramp. The present drivers pushed vehicle 'B' up the ramp and stopped it on the flat part of the ramp.

It is recommended that internal procedures and instructions be updated to take additional measures to ensure the safety of bystanders in the event of vehicle engine failures or malfunctions during the provision of services in the ship's hold and especially in difficult areas such as the ramps between the decks. .

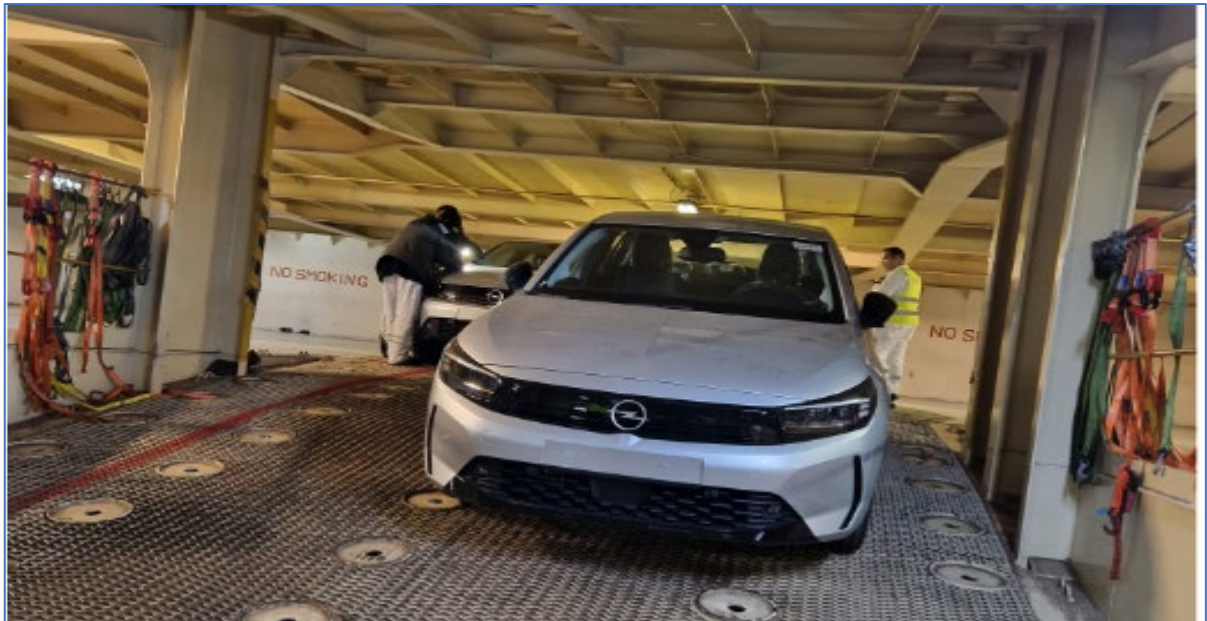
- Vehicle "A" was on the lower part of the ramp at the time. The driver of vehicle 'A' reversed up the ramp and collided with vehicle 'B', which was stationary at the top of the ramp, and with the driver, who was at that moment alongside vehicle 'B'. The driver of vehicle 'B' was injured and the vehicle damaged by the collision (Figure 7).

Figure 7: Position of vehicle "A" after collision with vehicle "B" and injured person (source: VNC Luka Koper)

- 3.3. At this time, the driver of vehicle "A", which was at the bottom of the ramp, was signalled by the signalman to reverse. Due to the position of the parked vehicle on the ramp, with the engine down, (presumably) fuel flowed into the front of the engine. As a result, the engine did not operate as expected (with the required power) and the driver repeatedly pushed the accelerator pedal. At a certain point, the engine (presumably) jumped to very high revs due to the increased fuel flow. At that moment, vehicle 'A' suddenly and rapidly moved in reverse and collided with the stationary vehicle 'B' at the top of the ramp and with the driver, who at that moment was still beside vehicle 'B', being moved by the other drivers. In the collision, the driver F.P. beside vehicle 'B' was injured and both vehicles damaged.
