# SIMPLIFIED REPORT FOR LESS SERIOUS CASUALTY BY THE RO-RO MORNING POST

Drifting from quay in the Port of Koper

AIR, MARITIME AND RAILWAY  
ACCIDENT AND INCIDENT  
INVESTIGATION UNIT

**26. 07. 2023**

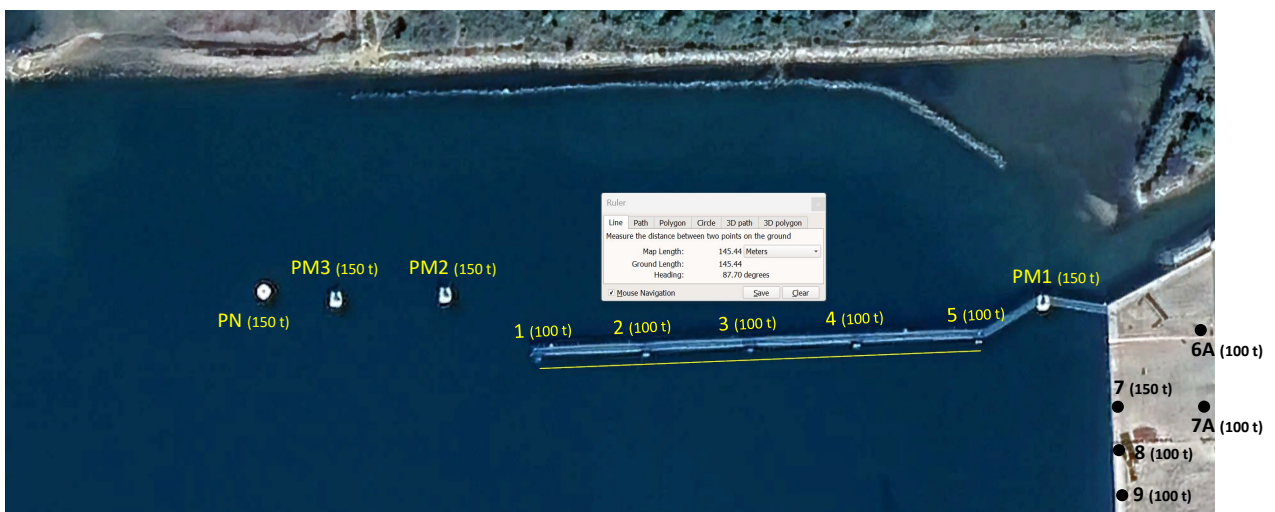
The berthing facilities at the terminal are: one 150 tons capacity mooring device, three moorinpoints each with three hooks with a total capacity of 150 tons, five bollards on the mooring dolphins (1, 2, 3, 4, 5) and the shore bollards (6A, 7, 7A, 8 and 9), all with a capacity of 100 tons. The geometry and the capacity of the moorings ensure the security of the berth.

Figure 7: Arrangement and load capacity of mooring points (PM) and mooring facilities (PN), (Luka Koper)

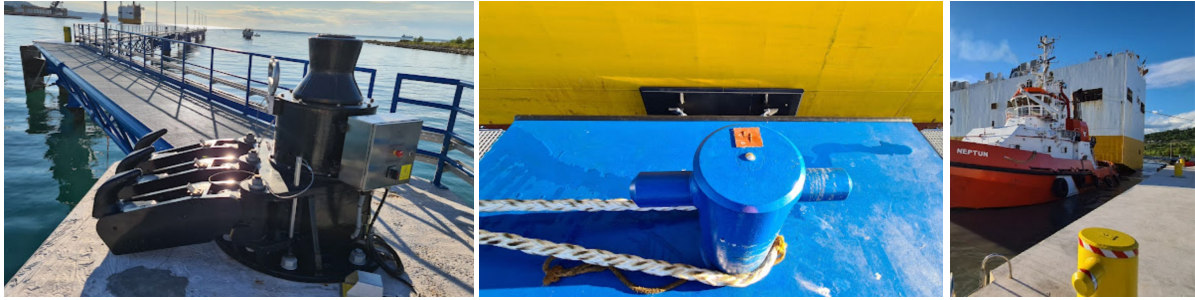
Figure 8: Mooring Hooks (PM), Bollards on mooring dolphins (1-5) and Shore bollards (6-9)

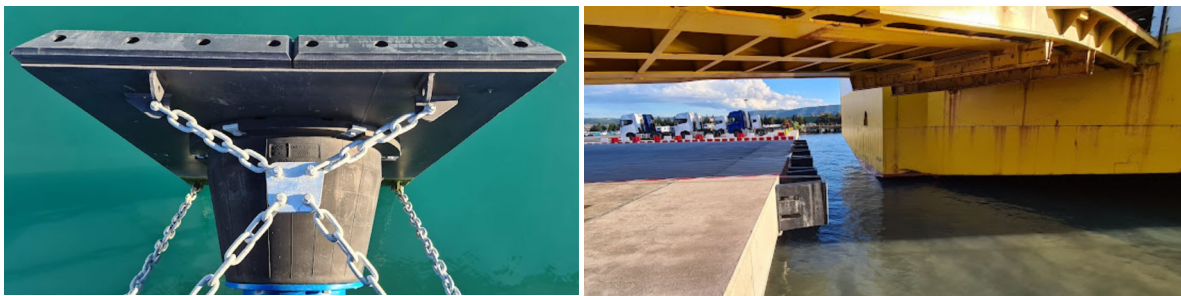
On each mooring dolphin there is one fender with characteristics of  $E=480 \text{ kNm}$  and  $R= 1020 \text{ kN}$ ,<sup>1</sup> which corresponds perfectly to the characteristics of RO-RO vessels and their safe berthing.

Figure 9: Fenders on mooring dolphins and fenders on access pier

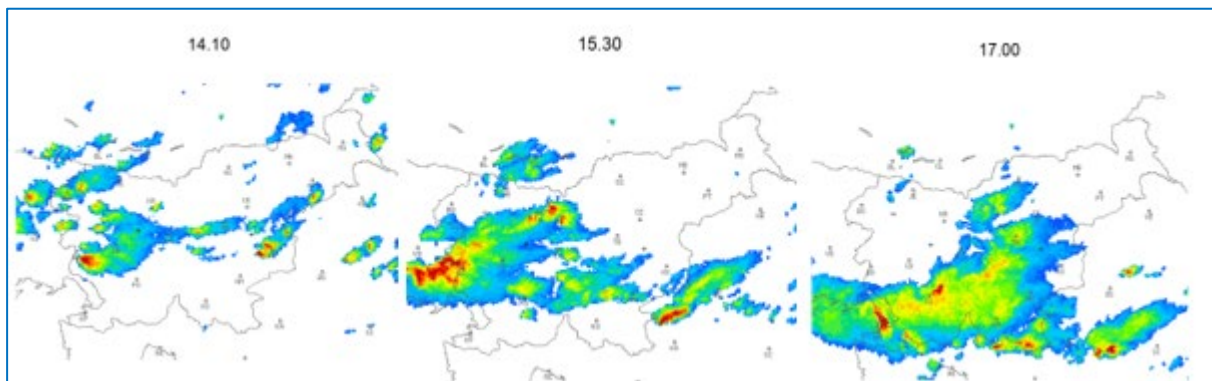
In view of the current weather situation and the forecasts of meteorological models, the National Meteorological Service has issued several warnings of storms and high heat load. In addition, the ship was in range of two NAVTEX stations (Slit and Mondolfo) which also forecast storms. Trieste Radio also broadcast a SECURITE message before the storm. The storm could already be visually observed one hour before the arrival of the storm. The radar reflectivity of the precipitation is shown in Figure 13.

Figure 13: Radar image of precipitation 26<sup>th</sup> July (ARSO)

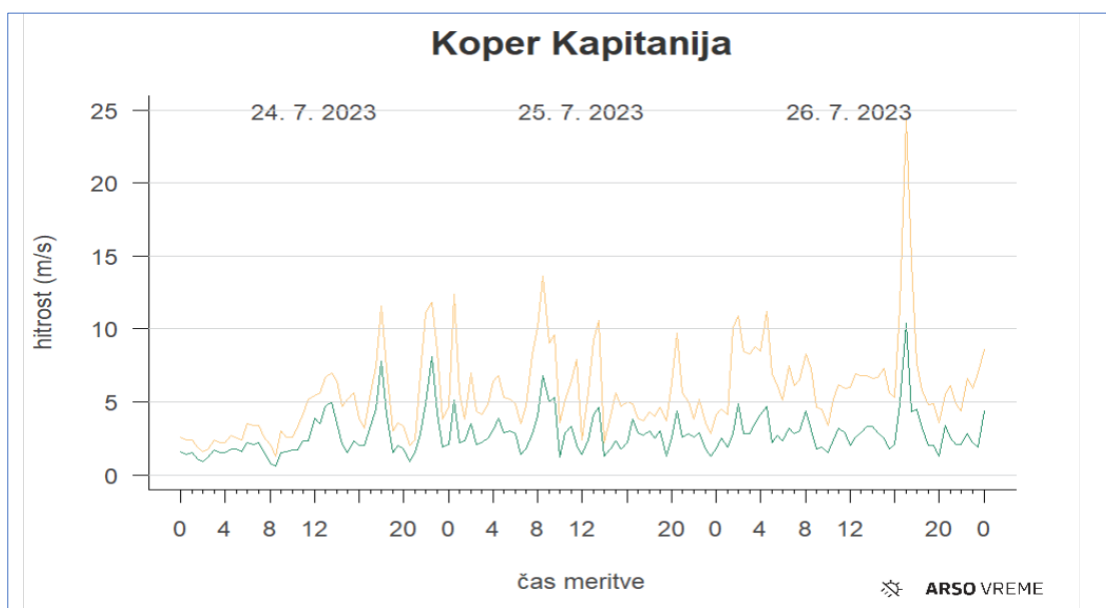
The strongest wind gusts were recorded between 16:20 and 17:20 on 26<sup>th</sup> July 2023 at the Koper Kapitanija gauging station (24.5 m/s). Figure 14 shows the time course of the average wind speed (green) and its strongest gusts (yellow) from 24 to 26 July at the Koper Kapitanija gauging station. At 16:00, the duty officer at the CNP issued a general warning on VHF channel 08 to all ships in the cargo port of Koper about the possibility of severe weather and strong winds ("Tramontane").

Figure 14: Time course of the average wind speed and its strongest gusts (ARSO)
