# SIMPLIFIED REPORT FOR MARINE INCIDENT BY THE M/V XIN BEIJING

Breakaway from quay in the Port of Koper  
26. 07. 2023

Izola, 31. 12. 2023

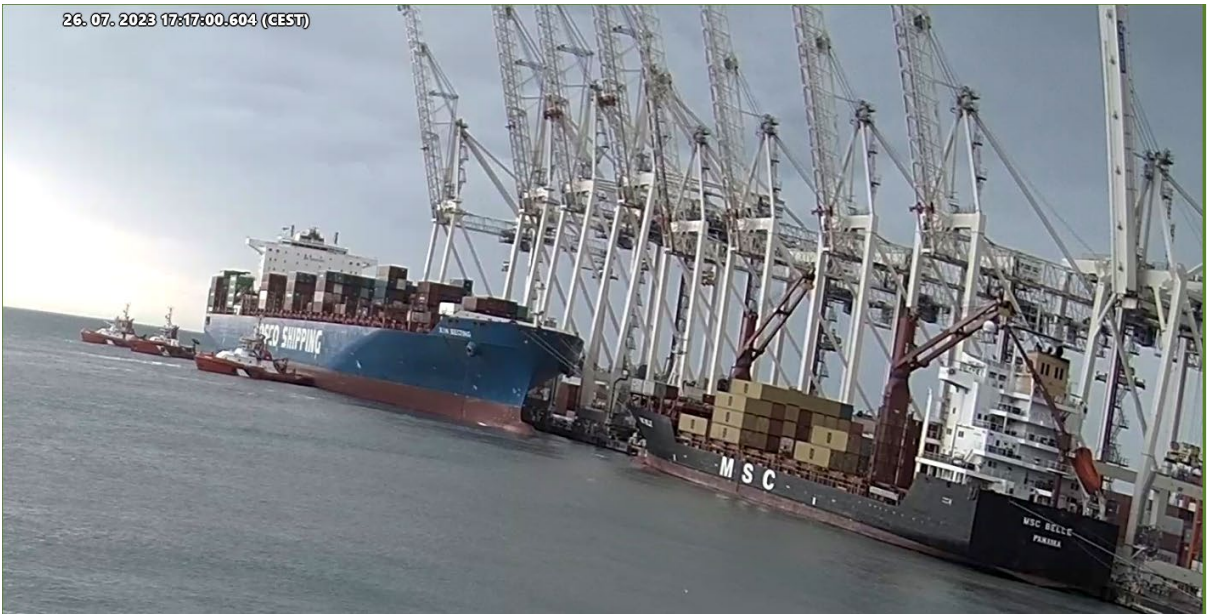
At 17:07:00, wind gusts started to decrease slightly to 19 m/s. The Xin Beijing was within 10 m of Berth 7C. The ship was pushed at 0,9 knots in a 320° direction. At 17:17:00 the Xin Beijing was safely positioned alongside (Figure 7), with winds of 9.5 m/s and gusts of 15.5 m/s. At 18:25 she was re-berthed, and the tugs were released.

Figure 7: M/V Xin Beijing re-berthed at Berth 7D (Source: VNC LK)

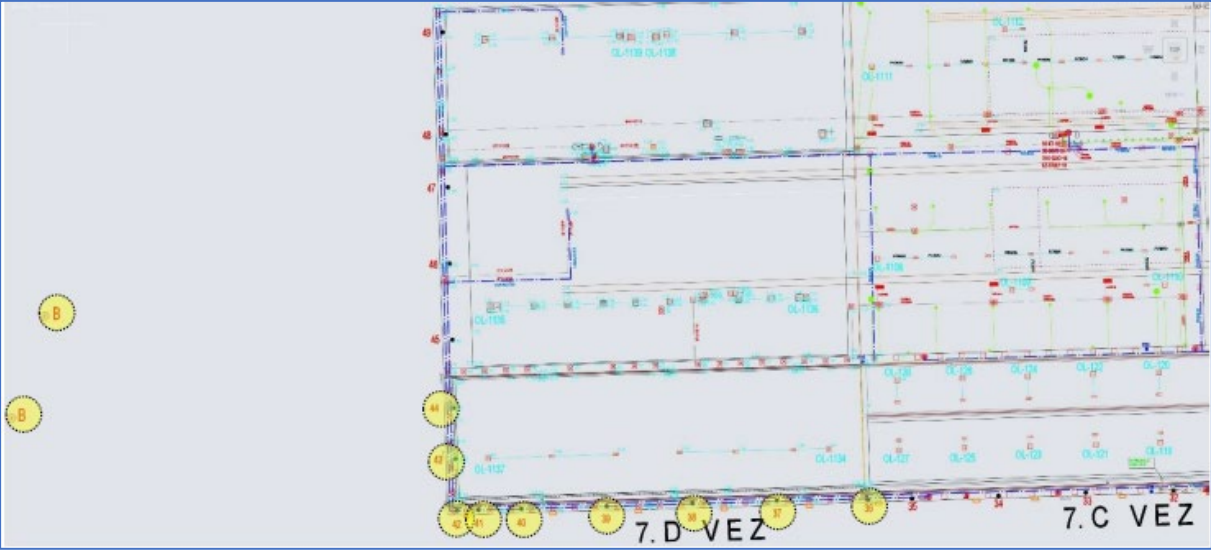
quay is also equipped with mooring bollards at the head of the quay, which are also of sufficient capacity (150 tons) to further strengthen the mooring. Two mooring devices (mooring buoys) of 250 tons capacity are anchored in the sea.<sup>3</sup> The use of the mooring devices is illustrated in Figure 10.

Figure 9: Overview of moorings and mooring facilities, Basin I, moorings 7D and 7C

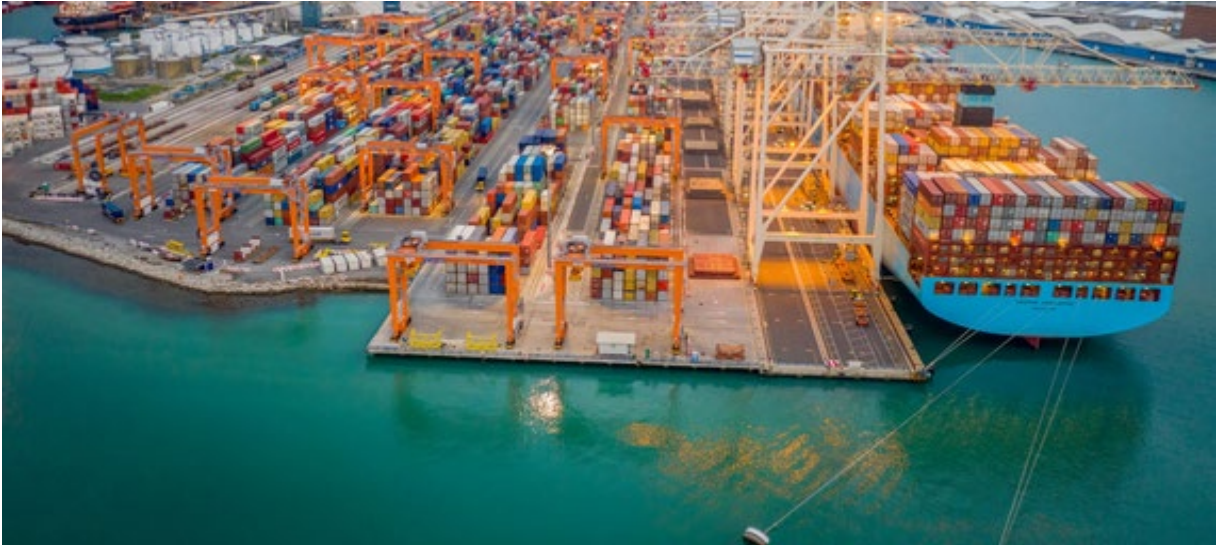
Figure 10: Illustration of the mooring of stern lines to mooring devices

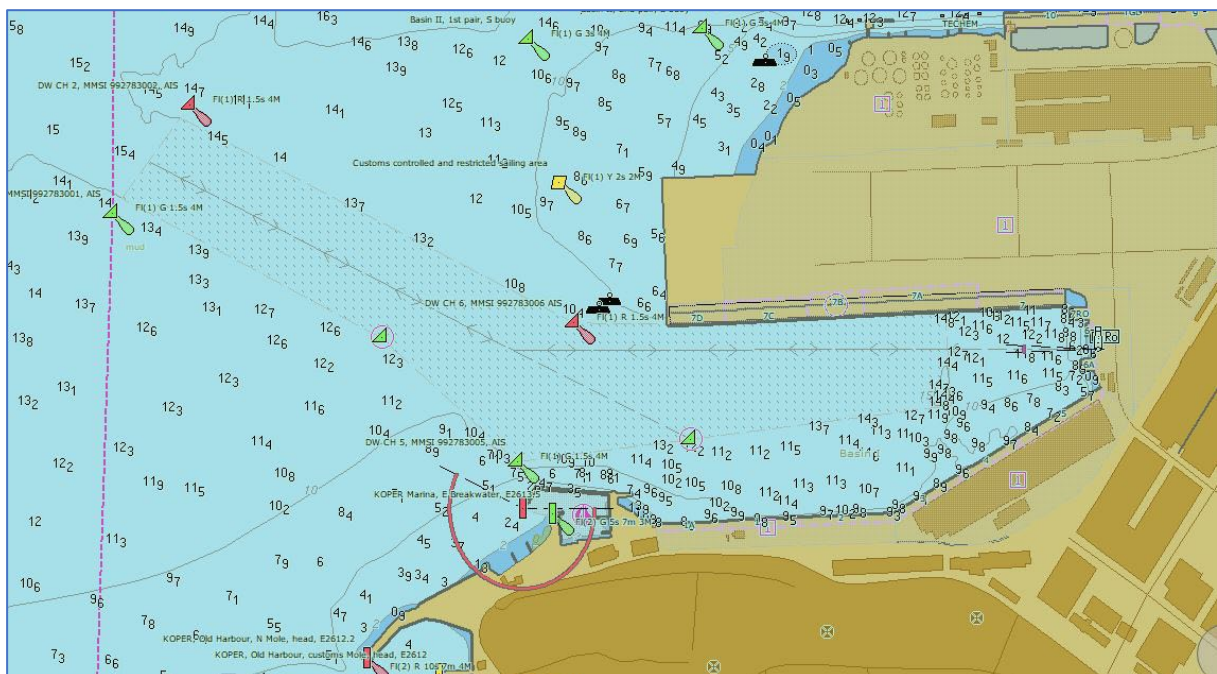
### 1.4.3. Hydrographic survey of the approach channel and Basin I

Figure 11: Extract of map ENC S15KP001, Pool 1 area with channel (-15 m) and depths plotted.

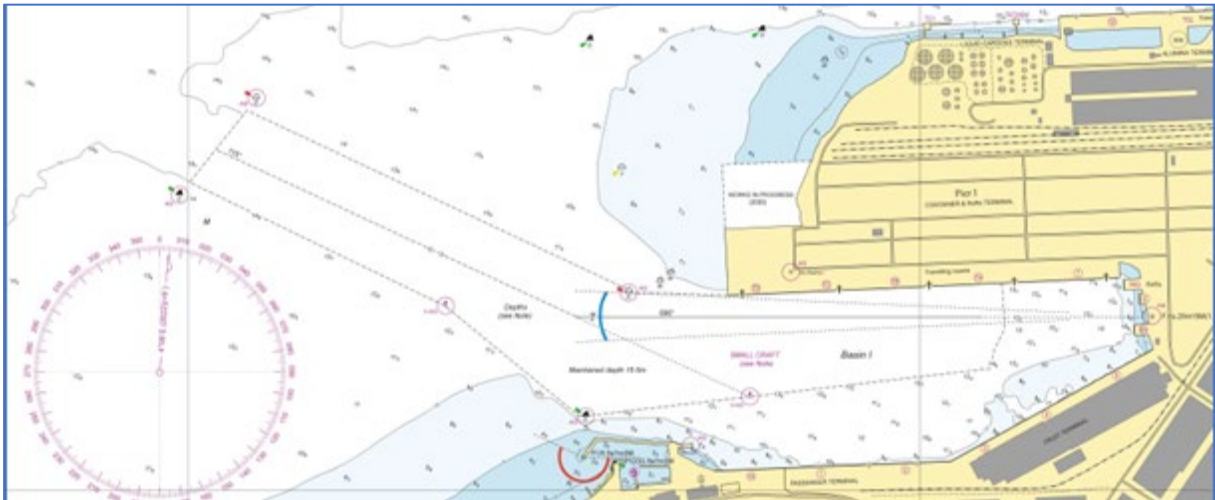
Figure 12 is an extract from the printed map. At the entrance itself, a bathymetric line (15 m) can be seen inside the channel, but this does not significantly affect safety as the ship follows the center of the channel.

Figure 12: Extract Official chart (paper) Port Koper 04 with channel plotted (-15 m)

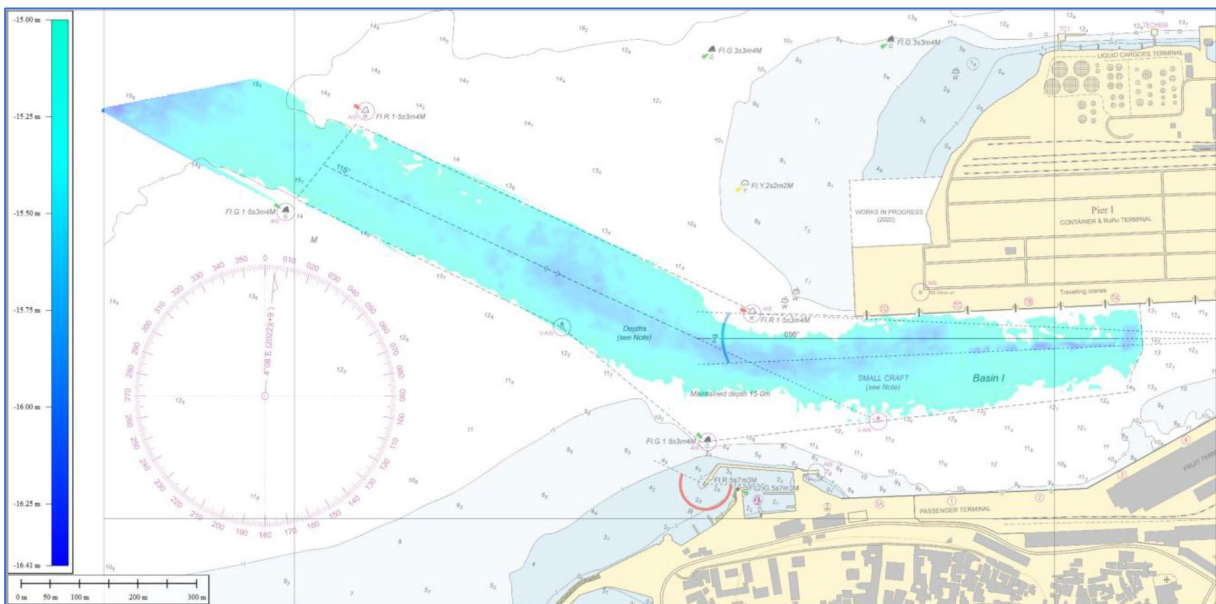
Figure 13 below gives a more detailed overview of the depths, showing an area with a depth of 15 m and more and an acceptable tolerance for navigation (the bottom is muddy), an area with a depth of 14.8 m and more in the pool area and 14.9 m and more in the inlet channel. The design of the channel and the availability of depths allow safe access to the mooring site, accurate positioning and a good and safe mooring to the available bollards and floating mooring devices.

Figure 13: Depths, 14.9 m and over for the inlet channel and 14.8 m and over for the basin

The design of the channel and the availability of depths allow safe access to the mooring site, accurate positioning and a good and safe mooring to the available bollards and floating mooring devices.

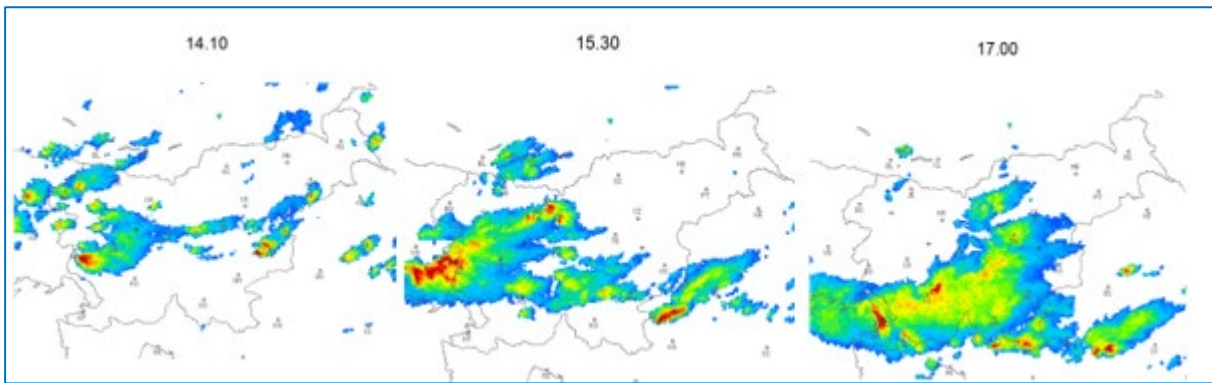
In view of the current weather situation and the forecasts of meteorological models, the National Meteorological Service has issued several warnings of storms and high heat load. In addition, the ship was in range of two NAVTEX stations (Slit and Mondolfo) which also forecast storms. Trieste Radio also broadcast a SECURITE message before the storm. The storm could already be visually observed one hour before the arrival of the storm. The radar reflectivity of the precipitation is shown in Figure13.

Figure 14: Radar image on 26.07.2023((source: ARSO)

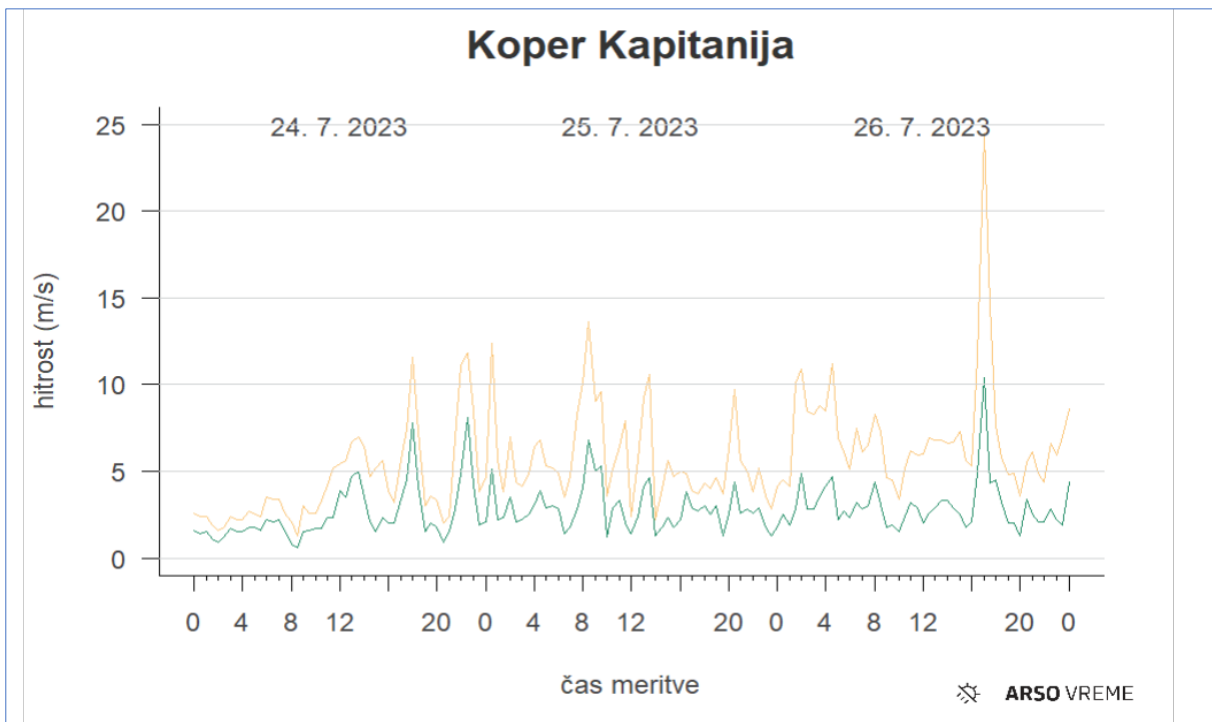
The strongest wind gusts were recorded between 16:20 and 17:20 on 26 July 2023 at the Koper Kapitanija gauging station (24.5 m/s). Figure 14 shows the time course of the average wind speed (green) and its strongest gusts (yellow) from 24 to 26 July at the Koper Kapitanija gauging station. At 16:00, the duty officer at the CNP issued a general warning on VHF channel 08 to all ships in the freight port of Koper about the possibility of severe weather and strong winds ("Tramontane").

Figure 15: Timeline of the average wind speed and its strongest gusts (source: ARSO)

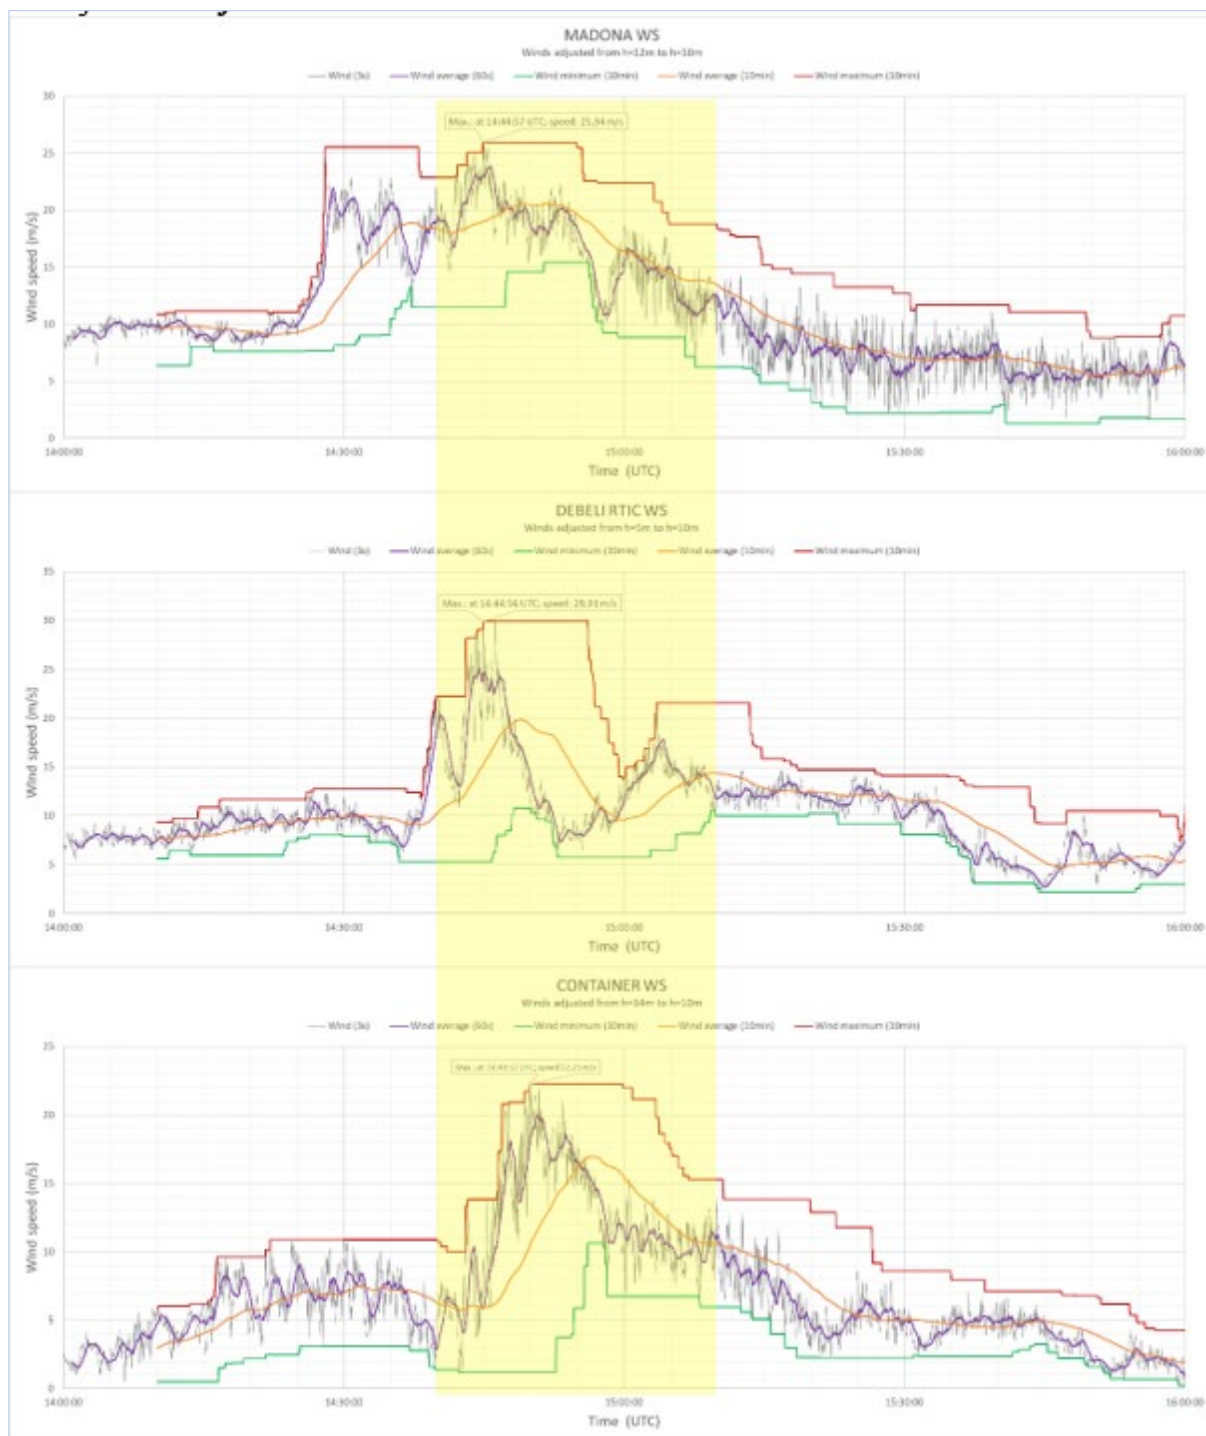
Figures show the wind direction and speed, as well as the wind gust direction and speed from the measuring stations at the container terminal of the Port of Koper, Cape Madona and Debele Rtič. The winds are converted to 10 m height in UTC record. The graphs show the values in the time window of the event that occurred on 26 July 2023 between 14:20 and 15:20 UTC. Winds averaged 7-17 m/s with maximum gusts up to 22.23 m/s from the north (tramontane), daylight visibility was good. Measured wind speeds ranged from 4 to 7 Beauforts (Bf) on the Beaufort scale, while maximum wind gusts were measured up to 9 Bf.

Overview data on wind speed (source: SMA, anemometers at Cape Madona, Debeli Rtič, LK container terminal, winds converted to 10m height, time in UTC)

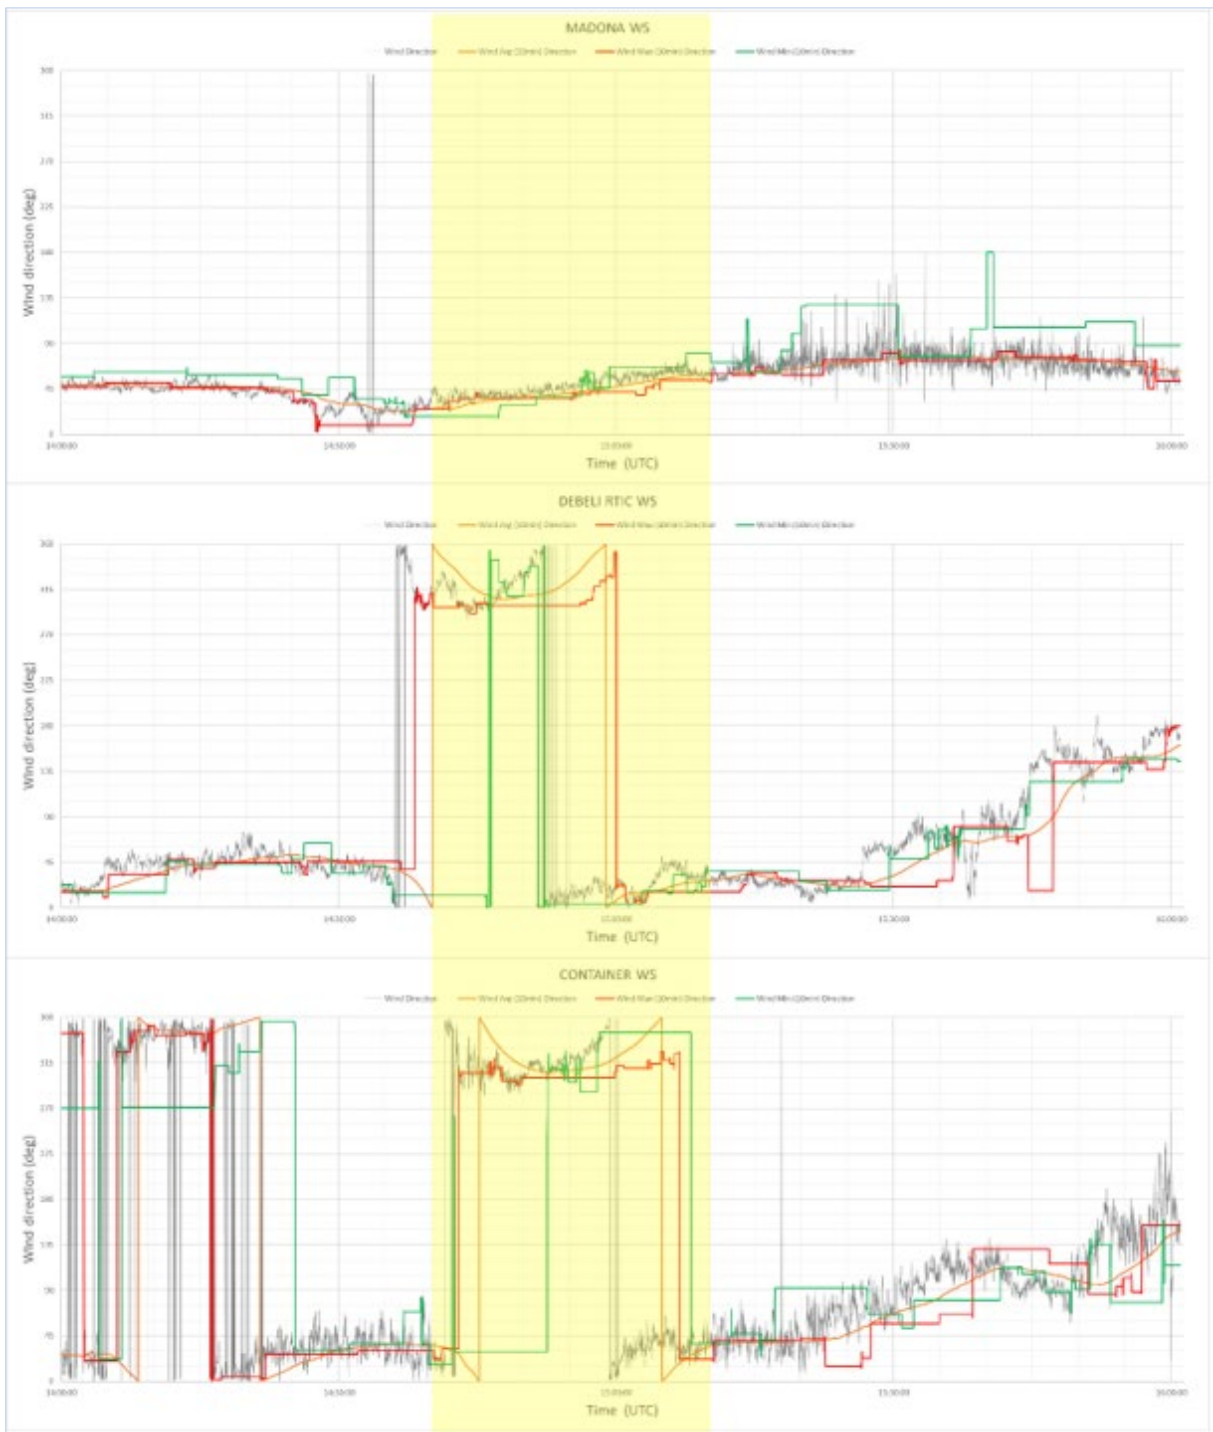
Overview data on wind directions (source: SMA, anemometers at Cape Madona, Debeli Rtič, LK container terminal, winds converted to 10m height, time in UTC)
