FINAL REPORT FOR SERIOUS CASUALTY ON M/V G TAISHAN

Personal injury of port worker during steel coils
discharging in Port of Koper, berth 11, Basin II
18. 05. 2024

18. 05. 2024

Marine Accident and Incident Investigator

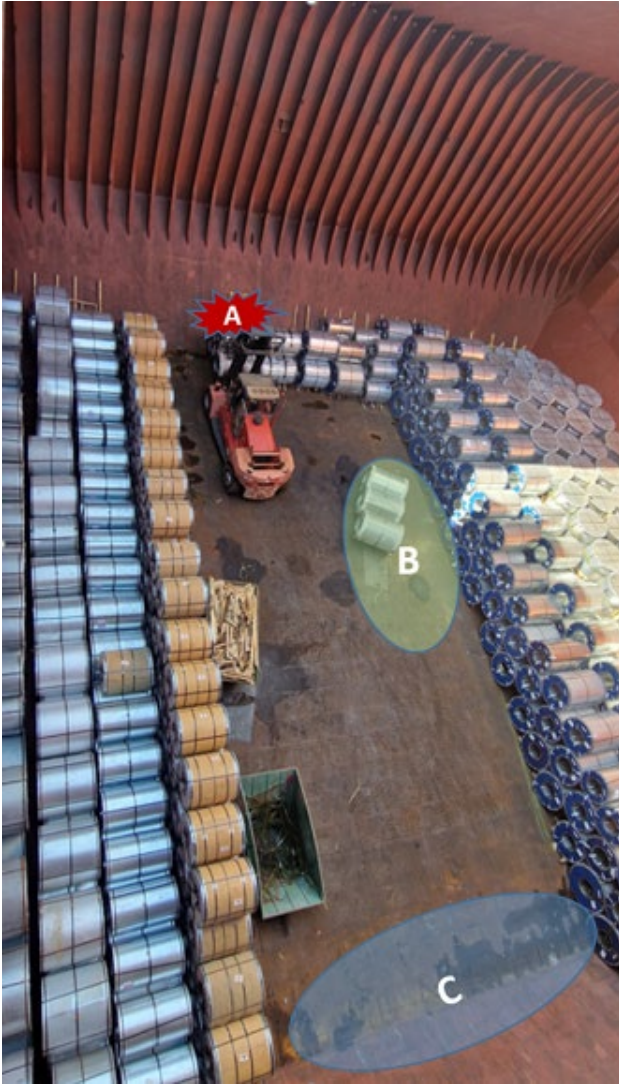
Figure 4: M/V G Taishan, Cargo hold no. 2

On May 18, 2024, before the start of work at around 0545 hours, a group of workers gathered in front of the General Cargo building and around 0550, they drove to the work site, berth 11, in a van. Upon arrival, the "ship crew," consisting of a foreman, a signalman, and four PTWs, was lowered into cargo hold No. 2 by the ship's crane using a basket. Figure 4 shows that the cargo for Koper in hold No. 2 was mostly unloaded during previous shifts.
