Ro-Ro Carrier "NEPTUNE AEGLI"

LOOSE MOORING ROPES DURING SUDDEN GUST OF
NNE WIND
IN PORT OF KOPER
ON
JULY 09, 2015

National occurrence no: 2/2015
EMCIP casualty No: 2483/2015

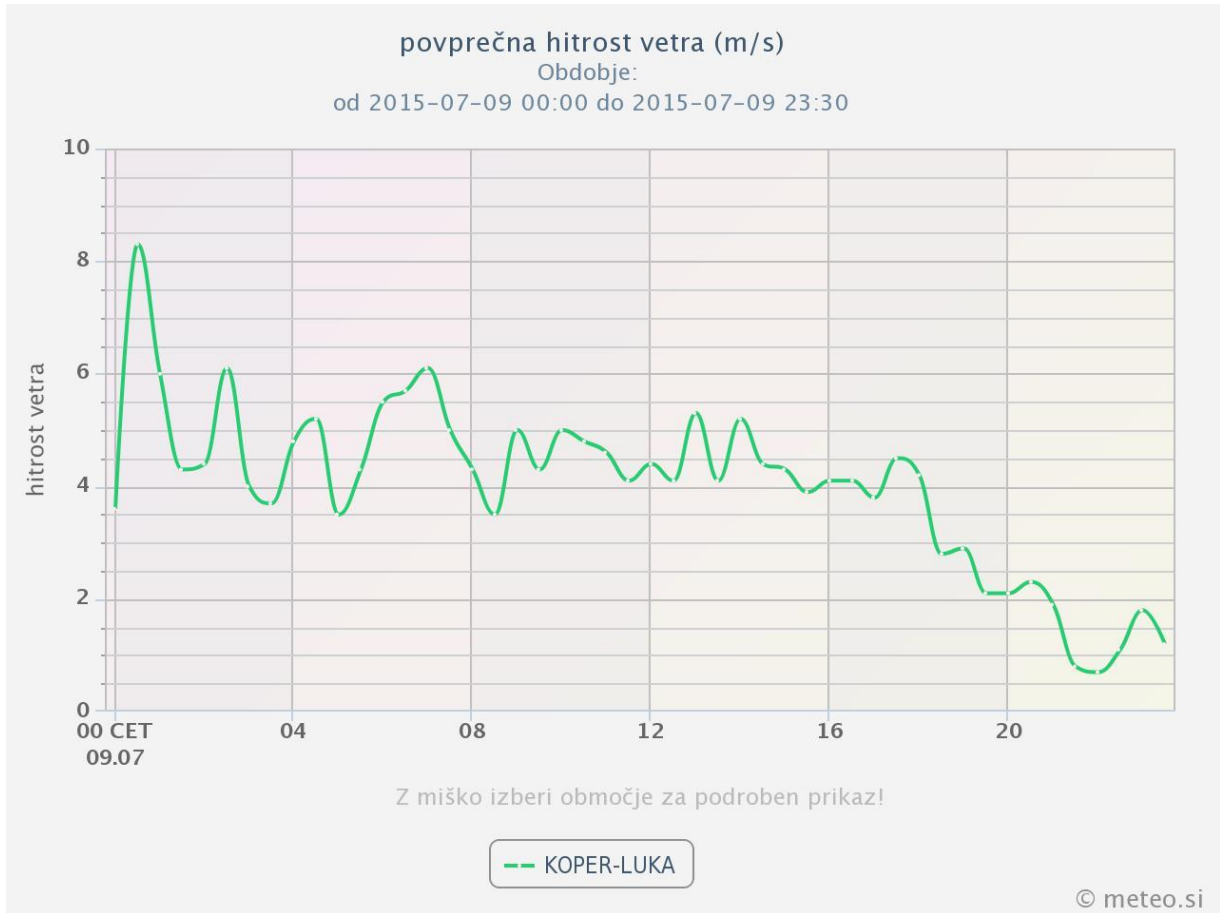
Figure 1: Average speed of wind (m/sec), Port of Koper, July 9, 2016

At 00:30hrs local time a sudden gust of NNE wind gale force 9 Bf (25,3 m/s) (Figure 1) hit the coastal area. Only four ships berthed on South berths were affected due to the location of the berths.

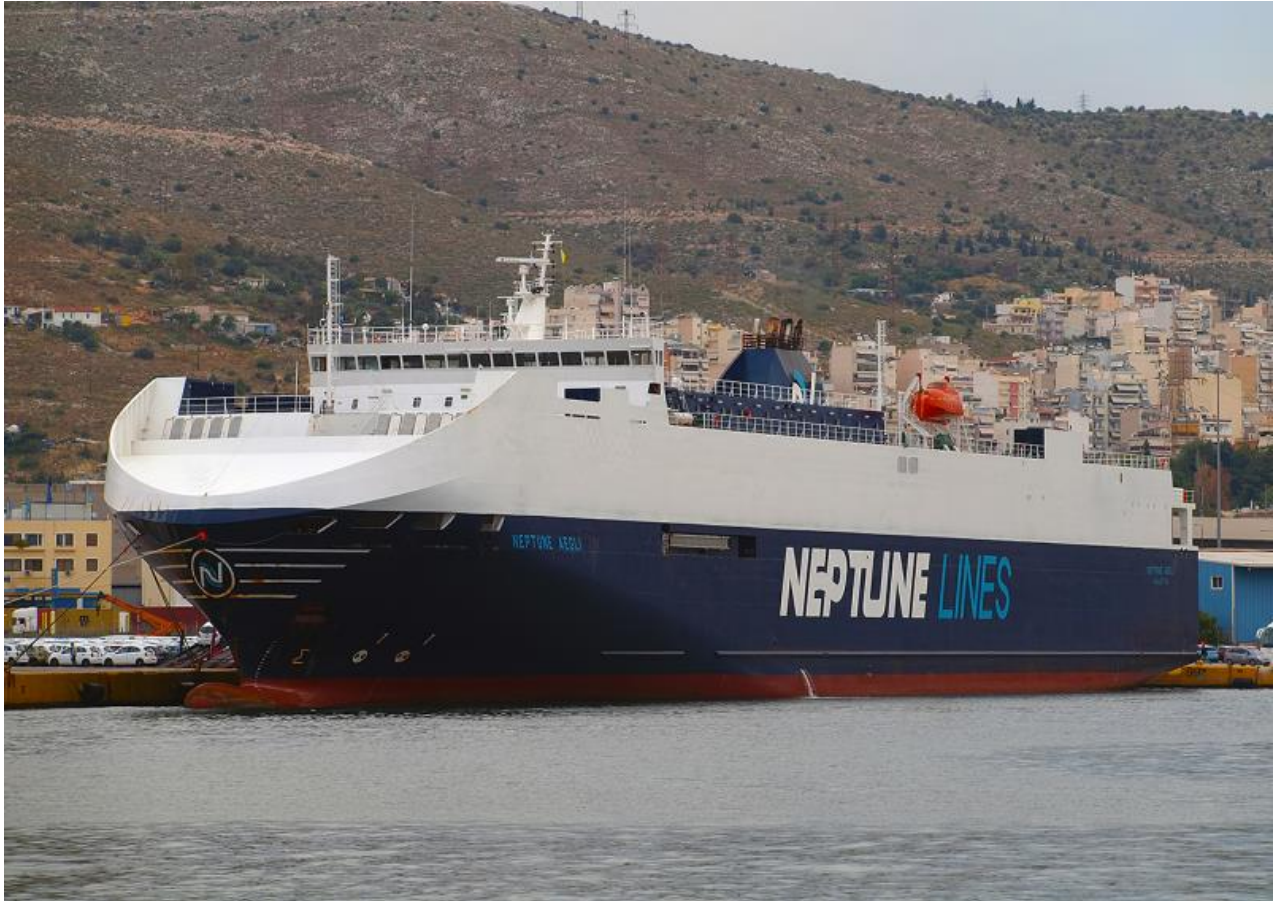
M/V »NEPTUNE AEGLI«

CALL SIGN:	9HEX7	FLAG:	MALTA
GROSS TONNAGE:	21.554 T	LOA/LPP	158,50m / 145,00m
YEAR BUILT:	2002	IMO NO:	9240964
