Ro-Ro Carrier "NEPTUNE ITHAKI"

LOOSE MOORING ROPES DURING SUDDEN GUST OF
NNE WIND
IN PORT OF KOPER
ON
JULY 09, 2015

National occurrence no: 2/2015
EMCIP casualty No: 3368/2016

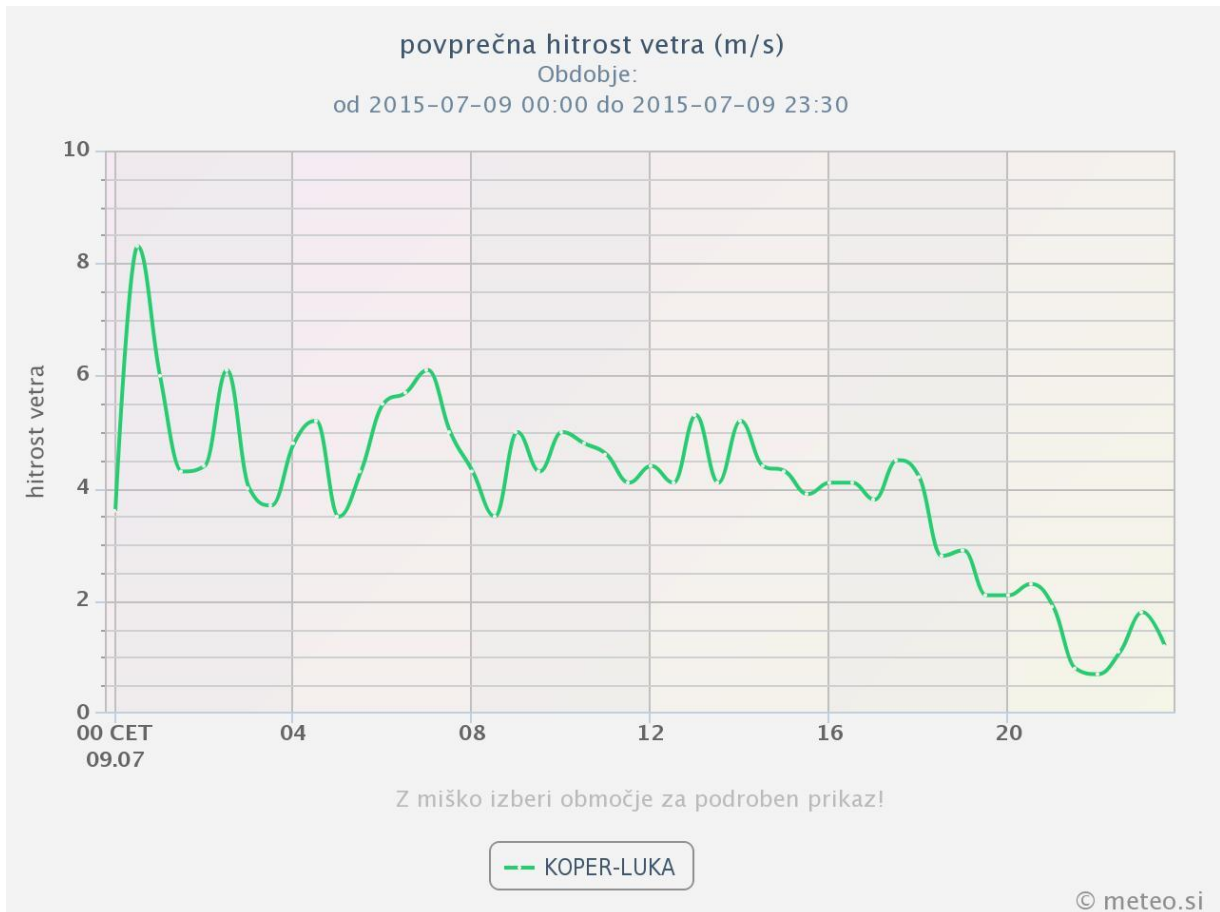
Figure 1: Average speed of wind (m/sec), Port of Koper, July 9, 2016

At 00:30hrs local time a sudden gust of NNE wind gale force 9 Bf (25,3 m/s) (Figure 1) hit the coastal area. Only four ships berthed on South berths were affected due to the location of the berths.

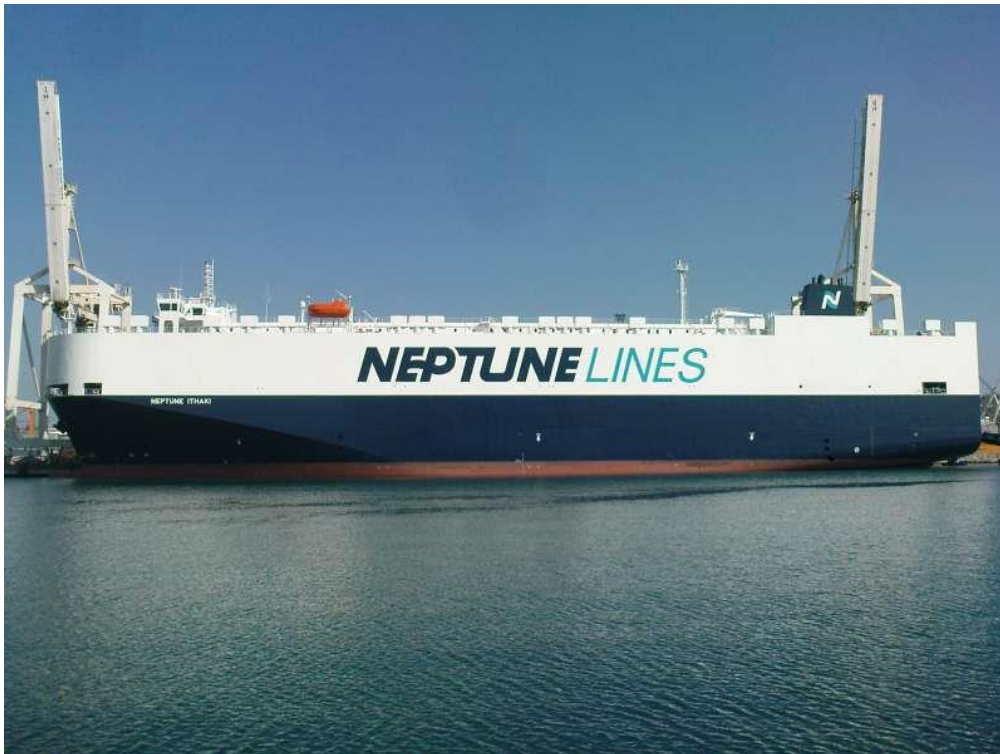
M/V »NEPTUNE ITHAKI«

She was berthed with her stern to the Ro-Ro berth, with both anchors and additional mooring lines forward. One tugboat was dispatched to assist her in case of emergency.

CALL SIGN: SVBS3	FLAG: GREECE
GROSS TONNAGE: 36.825 T	LOA/LPP 170,00m / 158,00m
YEAR BUILT: 2010	IMO NO: 9440083
